June 5, 2017

Re: Geotechnical Engineering Report for Hillview Drive Slope Repair
Vista Tassajara, Danville, California
SFB Project No.: 768-1

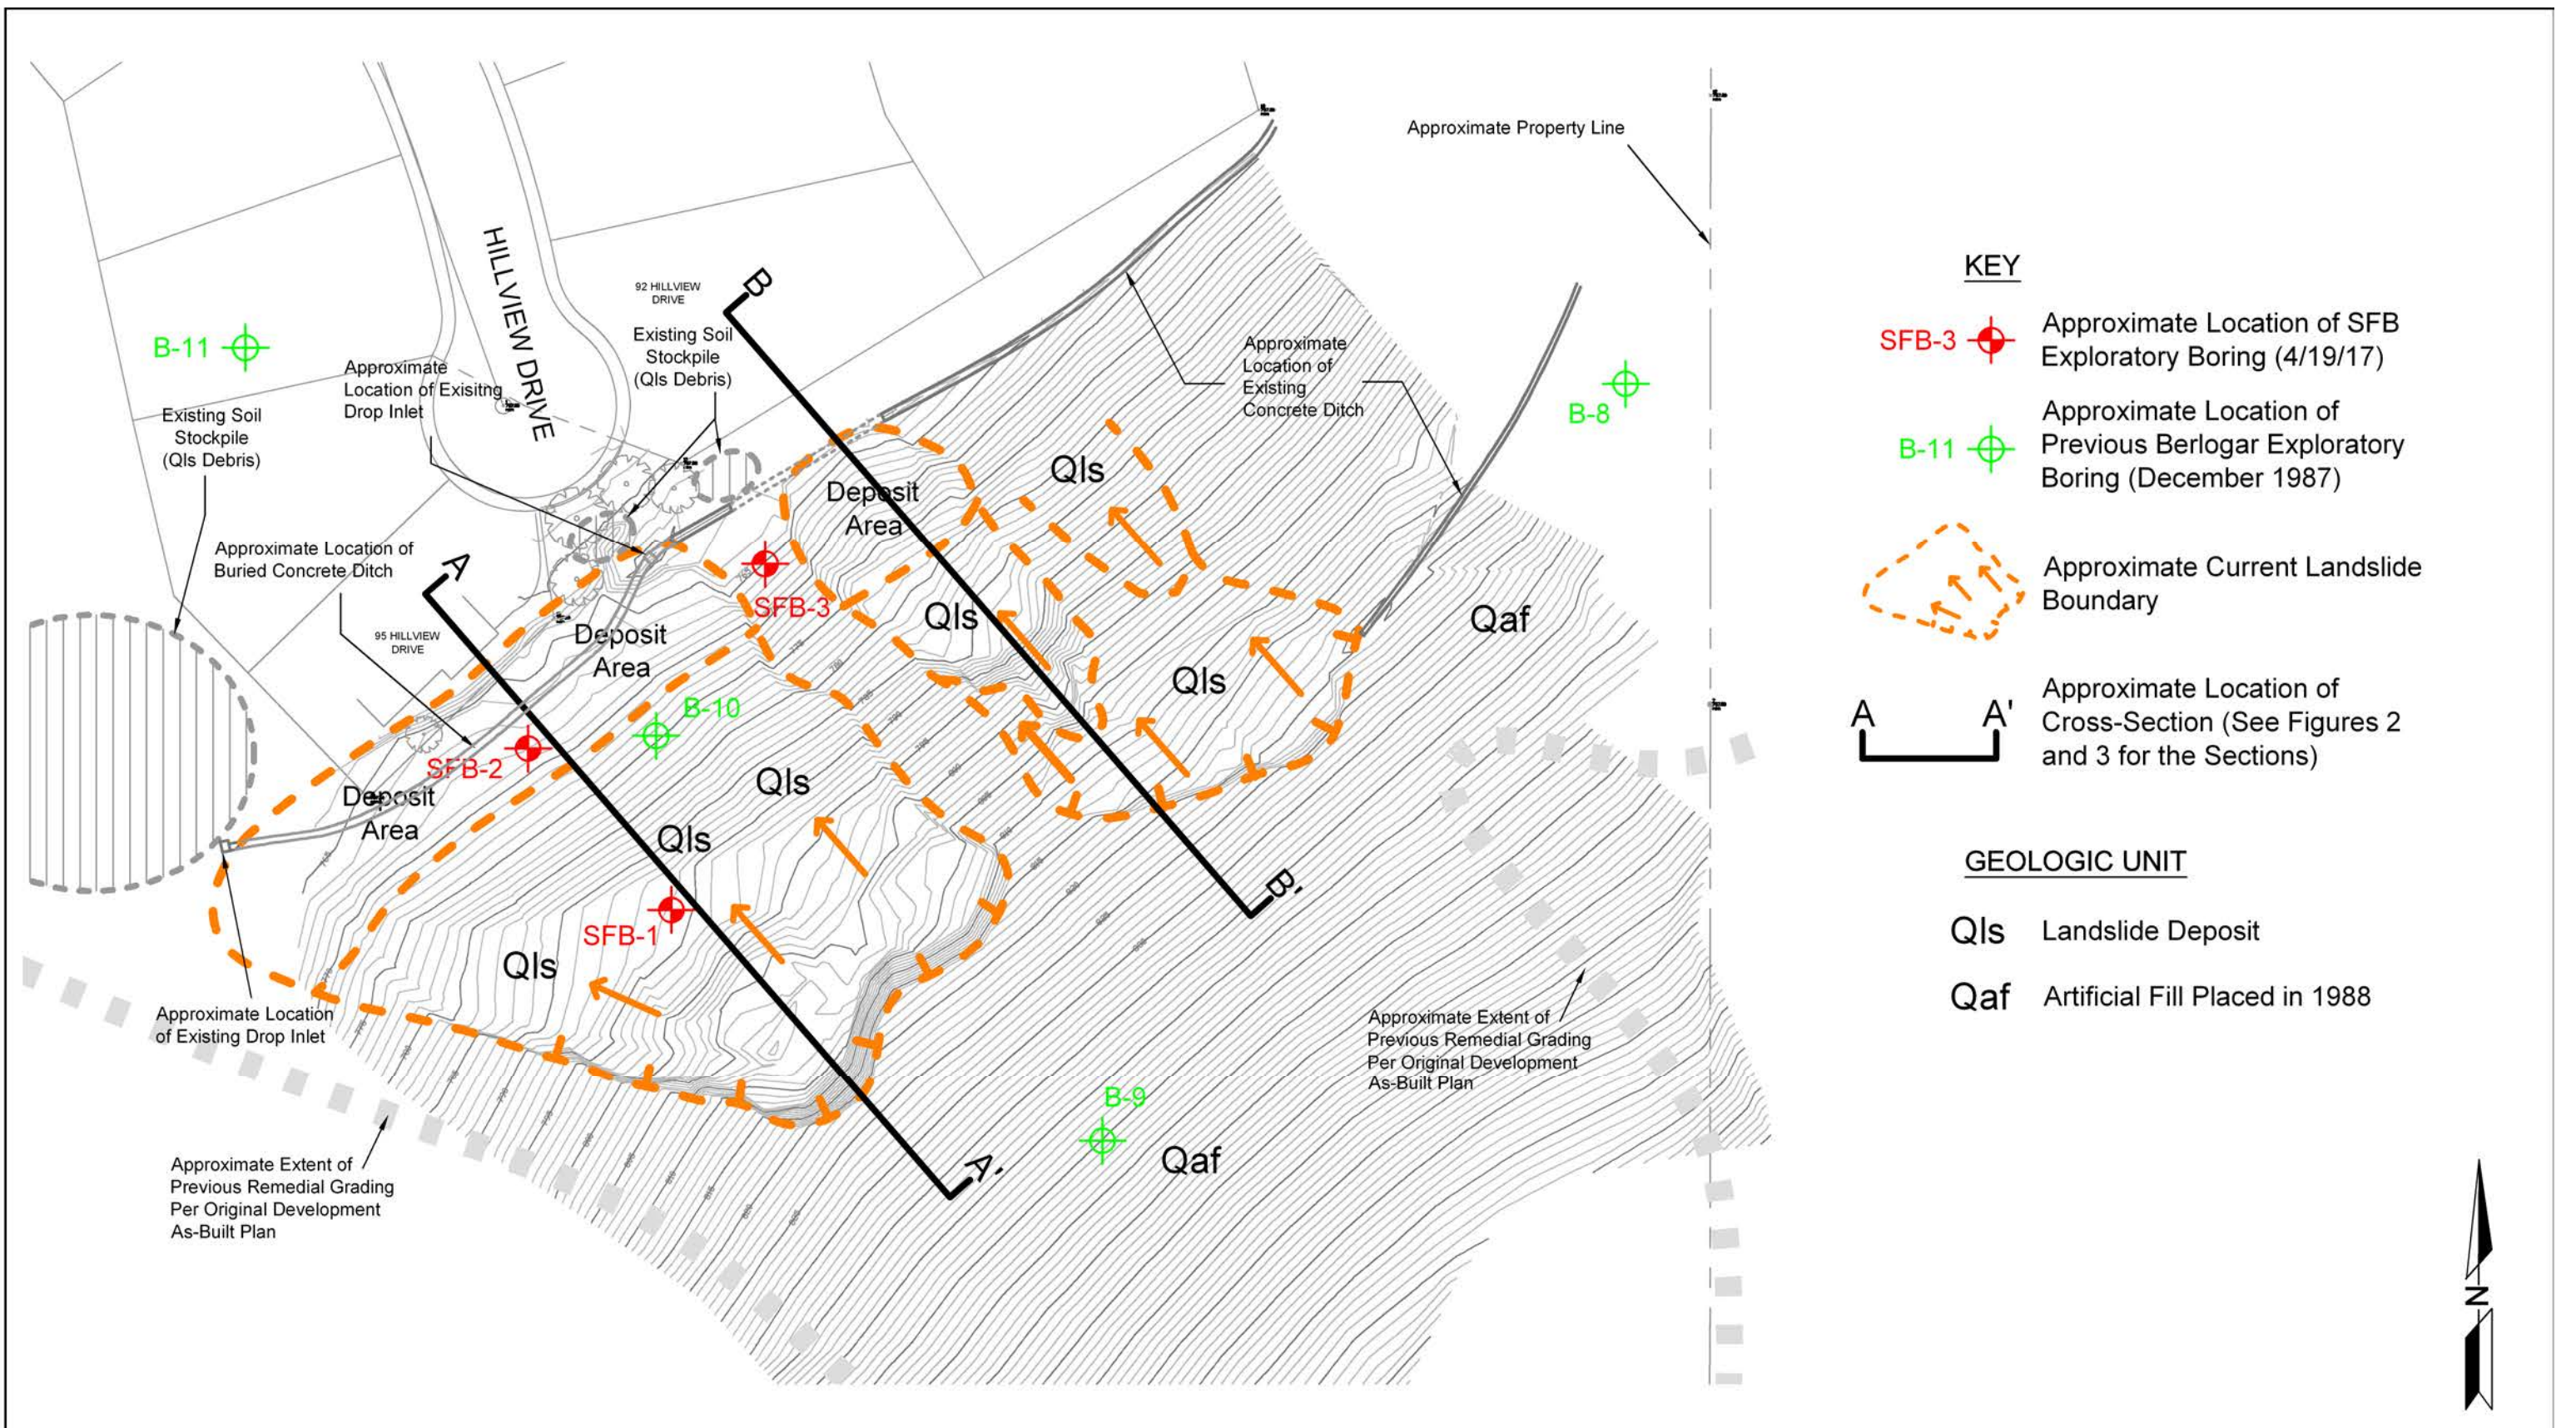
FIGURE
1

It is our understanding that a landslide occurred on the hillside above the southern terminus (cul-de-sac) of Hillside Drive during the winter of 2016/2017. As shown on the attached **Figure 1**, the landslide exists within open space land managed by the Vista Tassajara HOA. The toe of the landslide is located at the base of the slope and has negatively impacted the private lot and residence at 95 Hillview Drive, and has the potential for negatively impacting the private lot and residence at 92 Hillview Drive and Hillview Drive itself. The landslide has detrimentally damaged surface drainage (and possibly subsurface drainage) facilities on the slope. The damaged hillside requires repair otherwise additional landslide movement will occur in the future that can affect private lots, Hillview Drive, and non-subdivision property located to the east.

SITE PLAN AND ENGINEERING GEOLOGY MAP
HILLVIEW DRIVE SLOPE REPAIR
 Danville, California

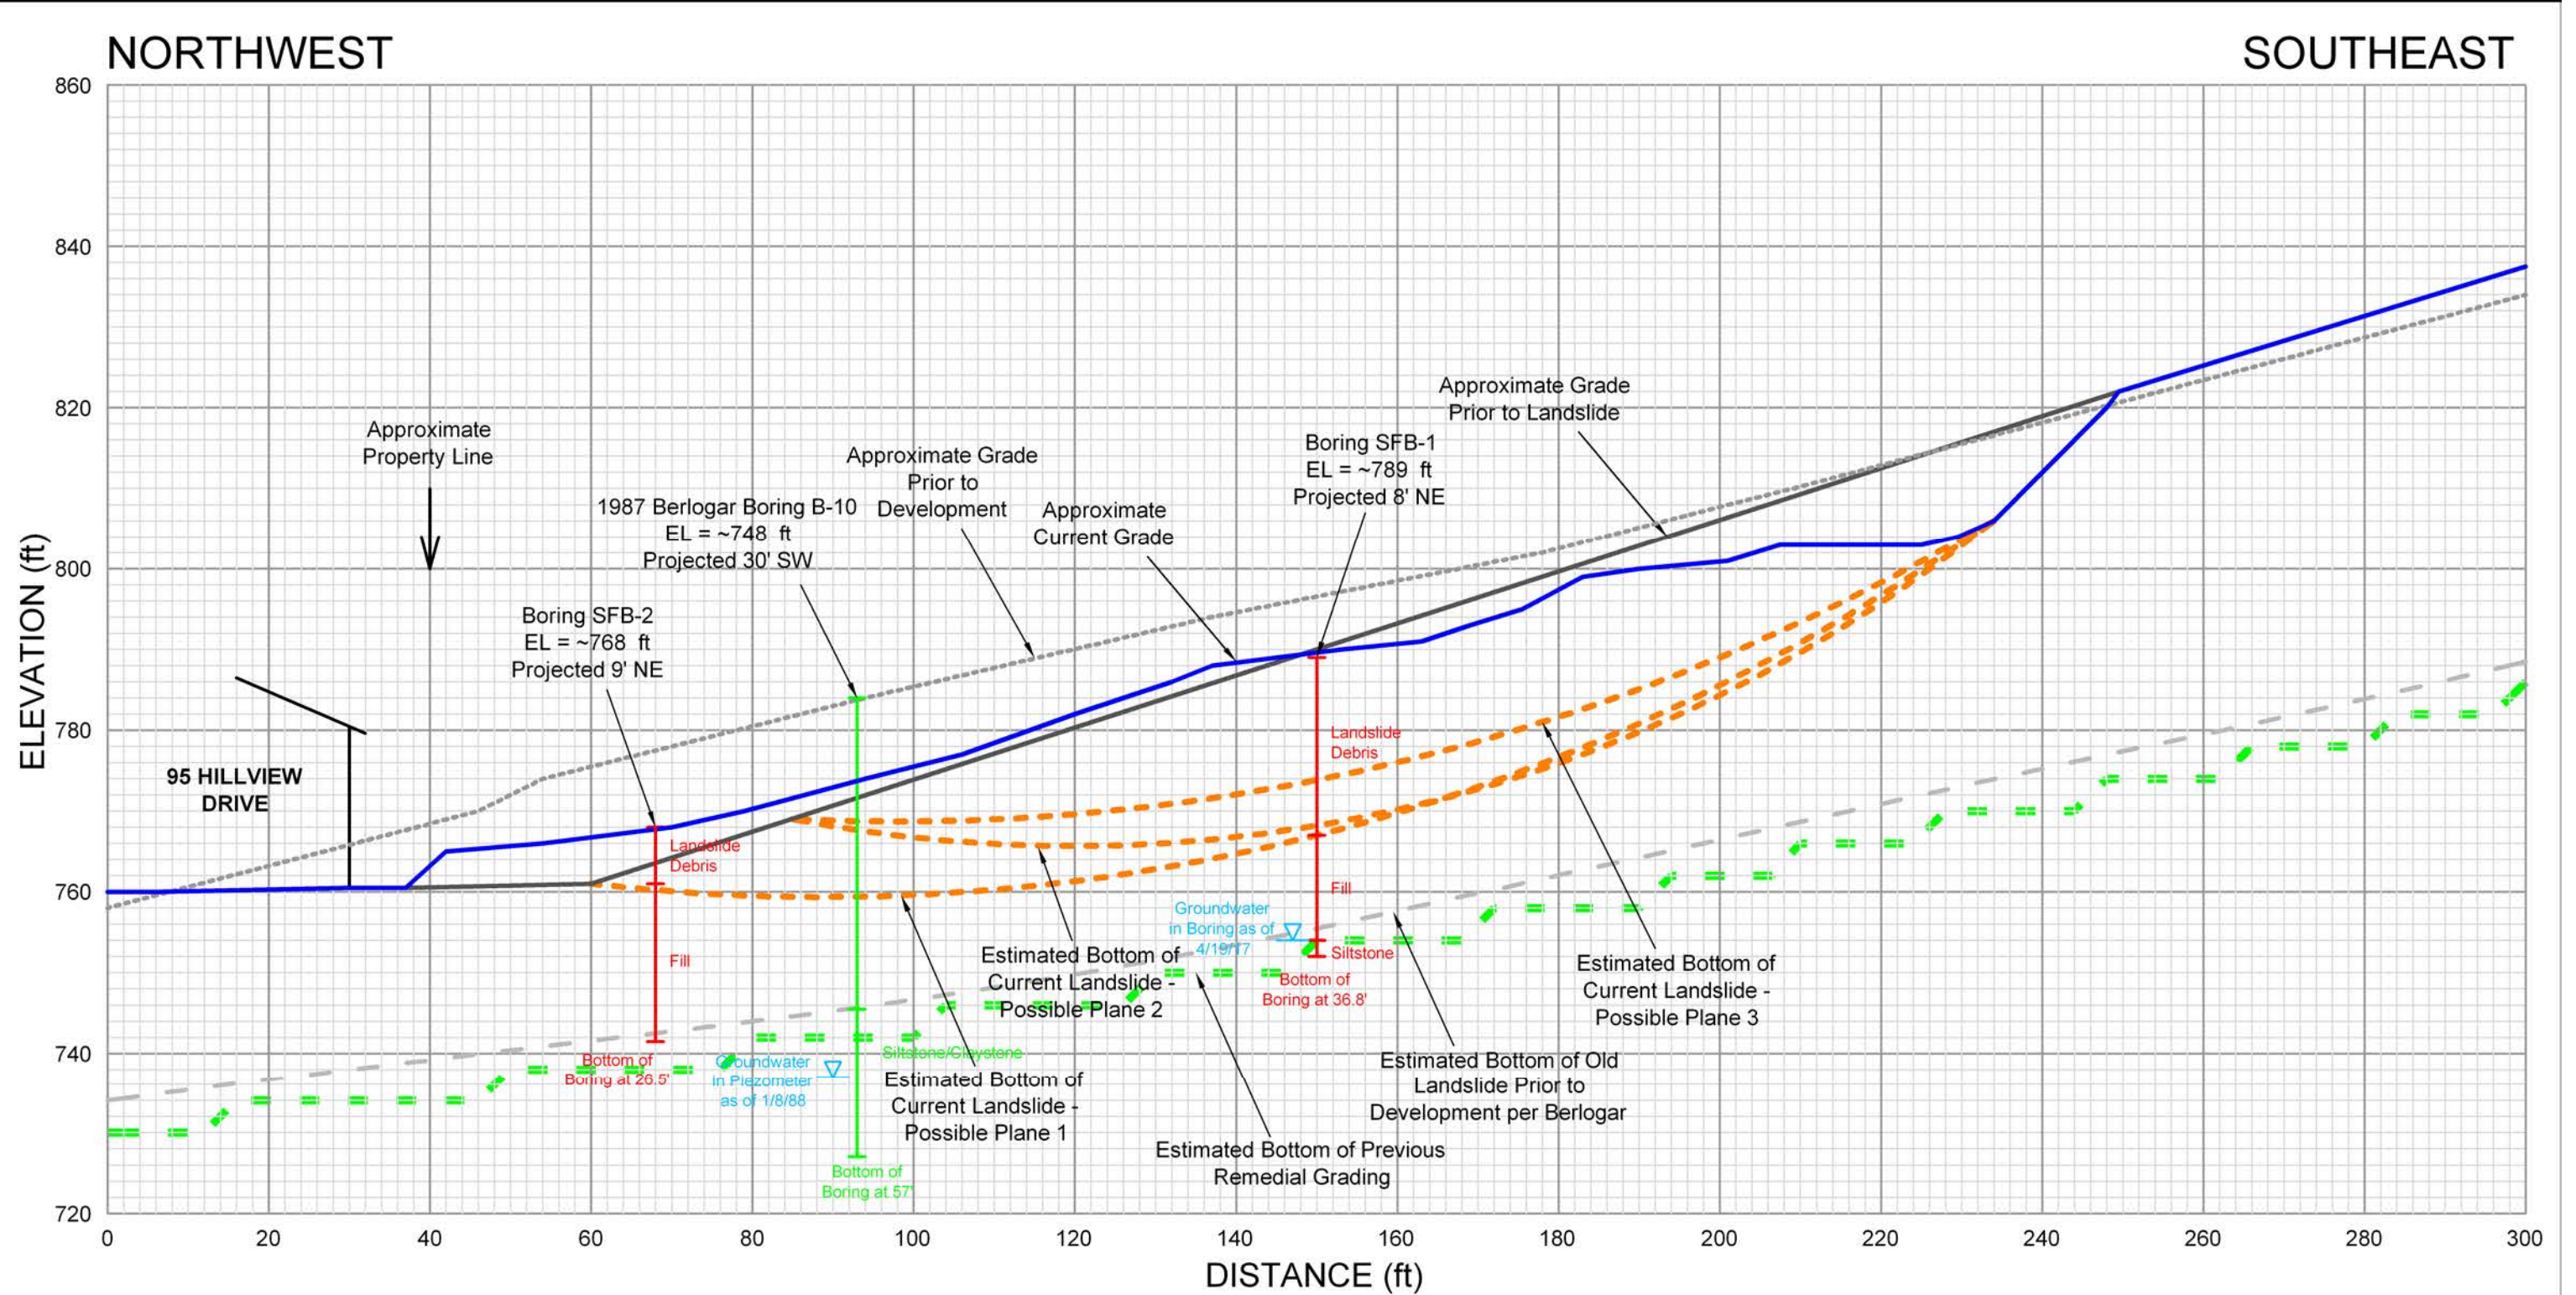
FIGURE
2

The attached Cross-Sections A-A' and B-B' (attached as **Figures 2 and 3**) show our interpretations of the estimated possible landslide planes and associated subsurface conditions based on the results of our field explorations and mapping. The locations of the sections are shown on **Figure 1**.

The representative Cross-Section A – A’ (**Figure 2**) was used in our slope stability analyses to back-calculate the frictional resistance at the time of hillslope failure along the three possible

slide planes and to evaluate the possible repair schemes. An estimated groundwater level at 5 feet below existing ground surface was used for the existing fill layer. The hillside friction angle was back-calculated to achieve a factor of safety of 0.99 against sliding under static condition. Our back-calculations results indicate the existing hillside fill materials along potential slide planes had a friction angle of about 25 to 26 degrees at the time of slope failure, which corresponds well with the remolded laboratory shear strength properties. This back-calculated frictional resistance also corresponds well with the upper bound, fully softened peak strength.

CROSS-SECTION A - A'
HILLVIEW DRIVE SLOPE REPAIR
 Danville, California

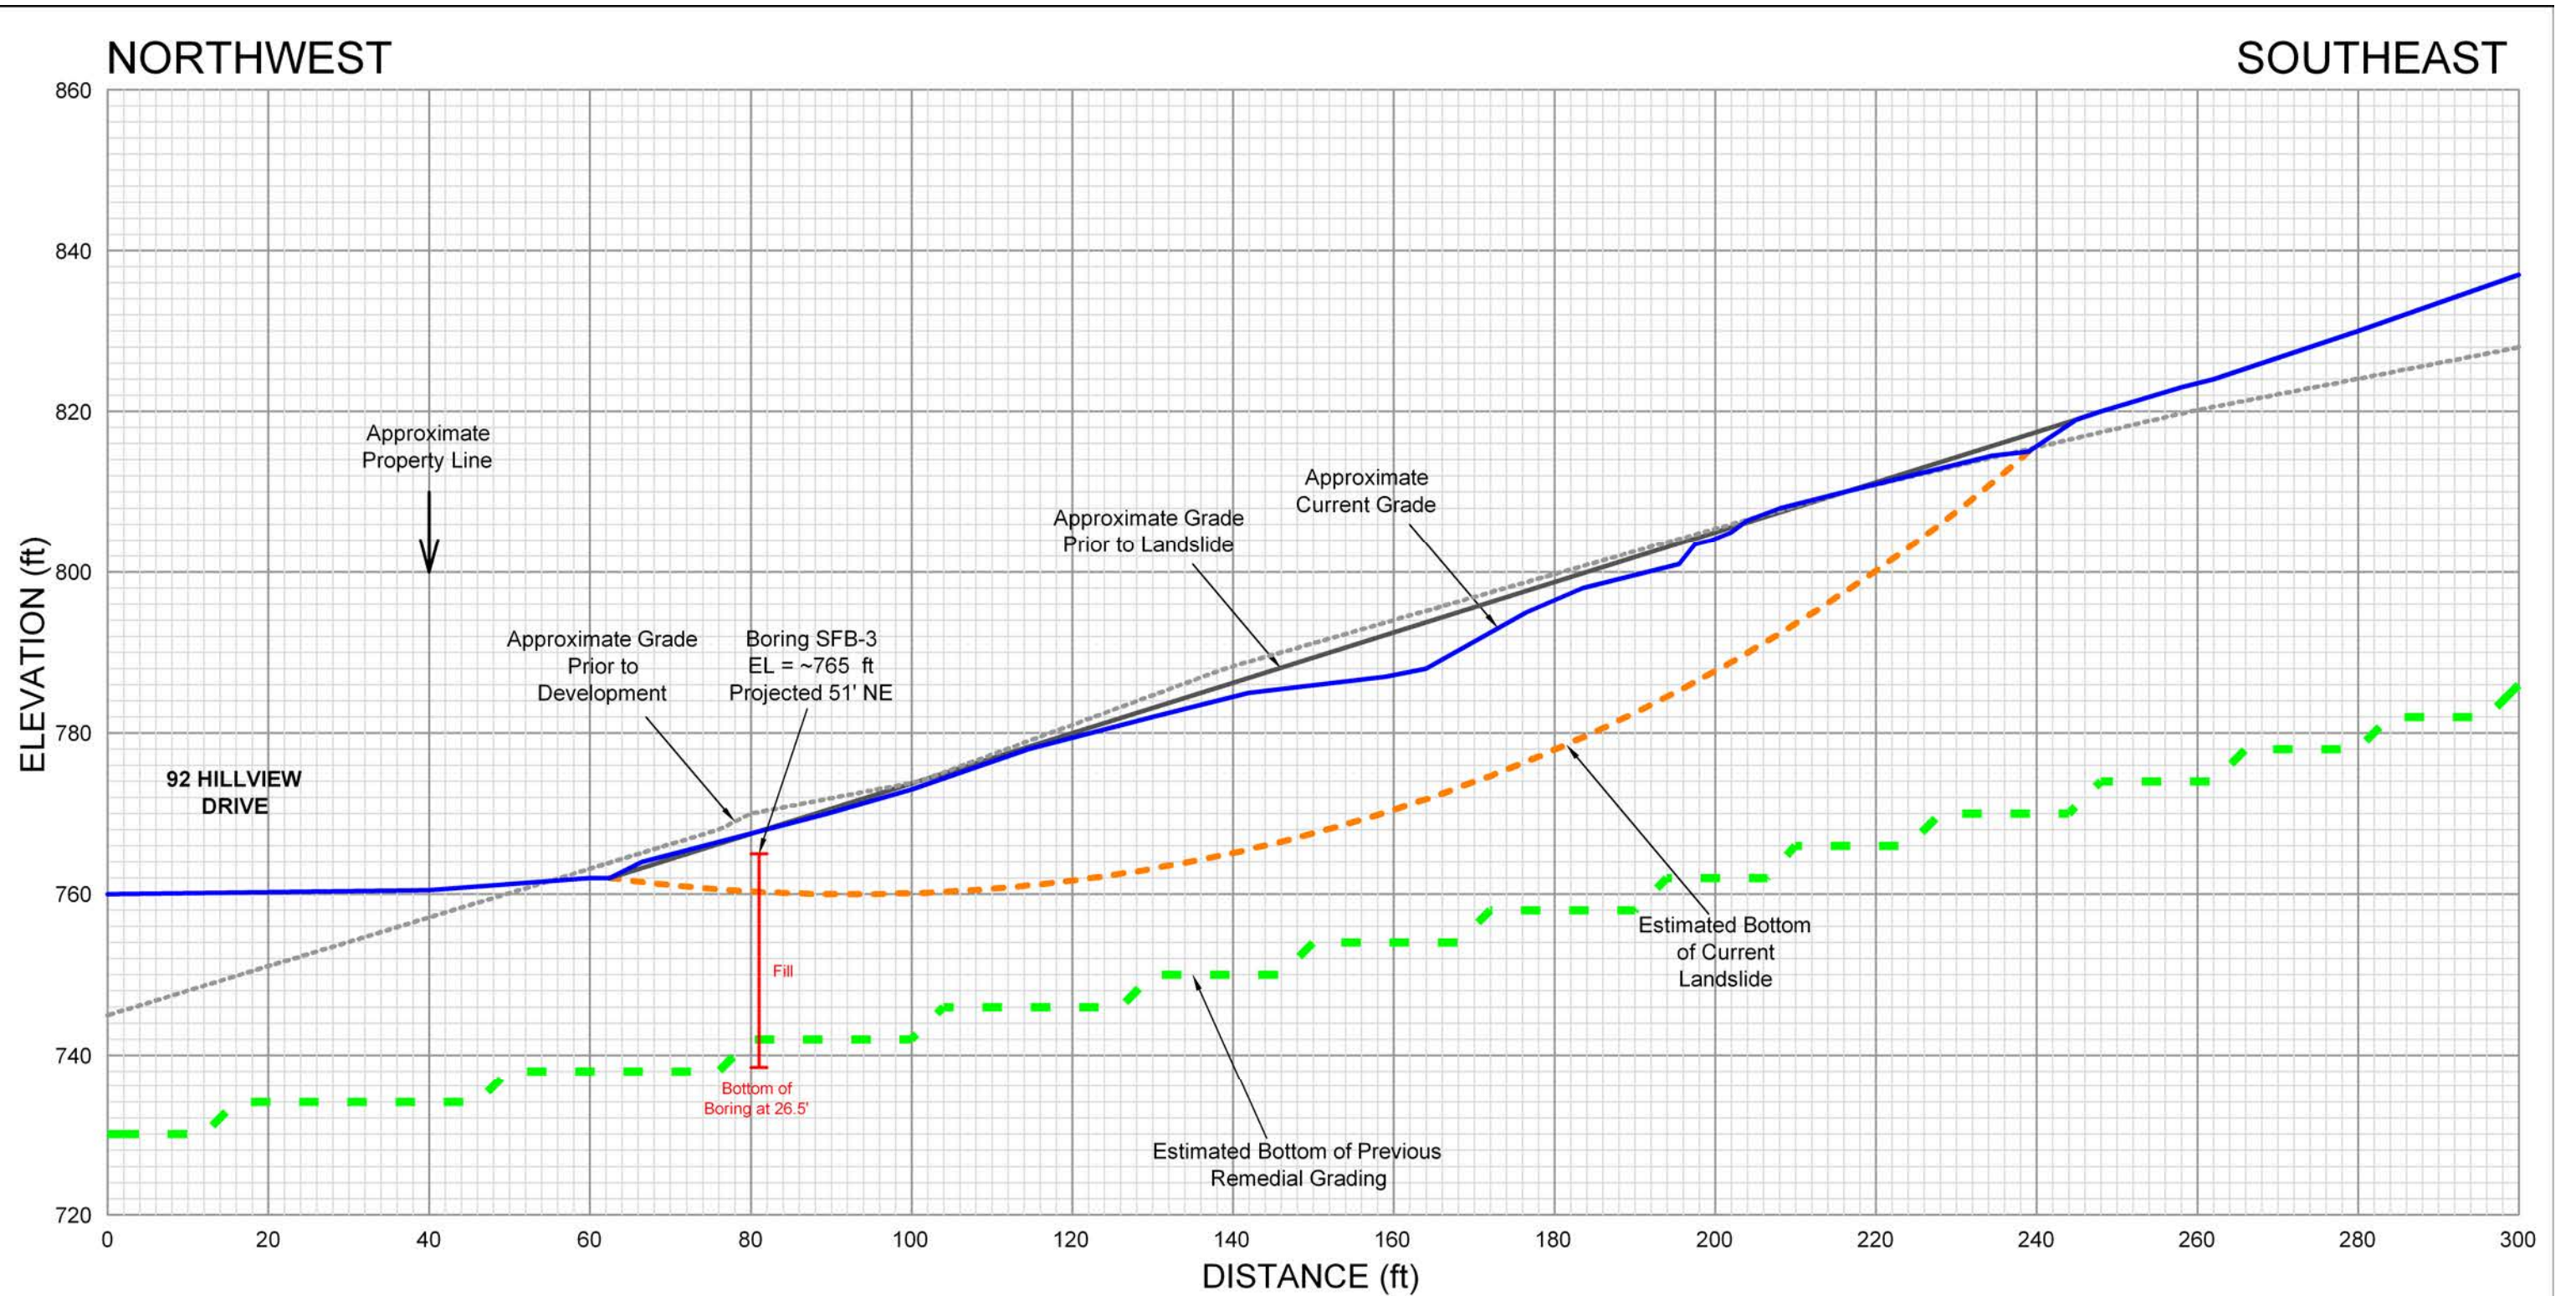
FIGURE
3

CROSS-SECTION B - B'
HILLVIEW DRIVE SLOPE REPAIR
Danville, California

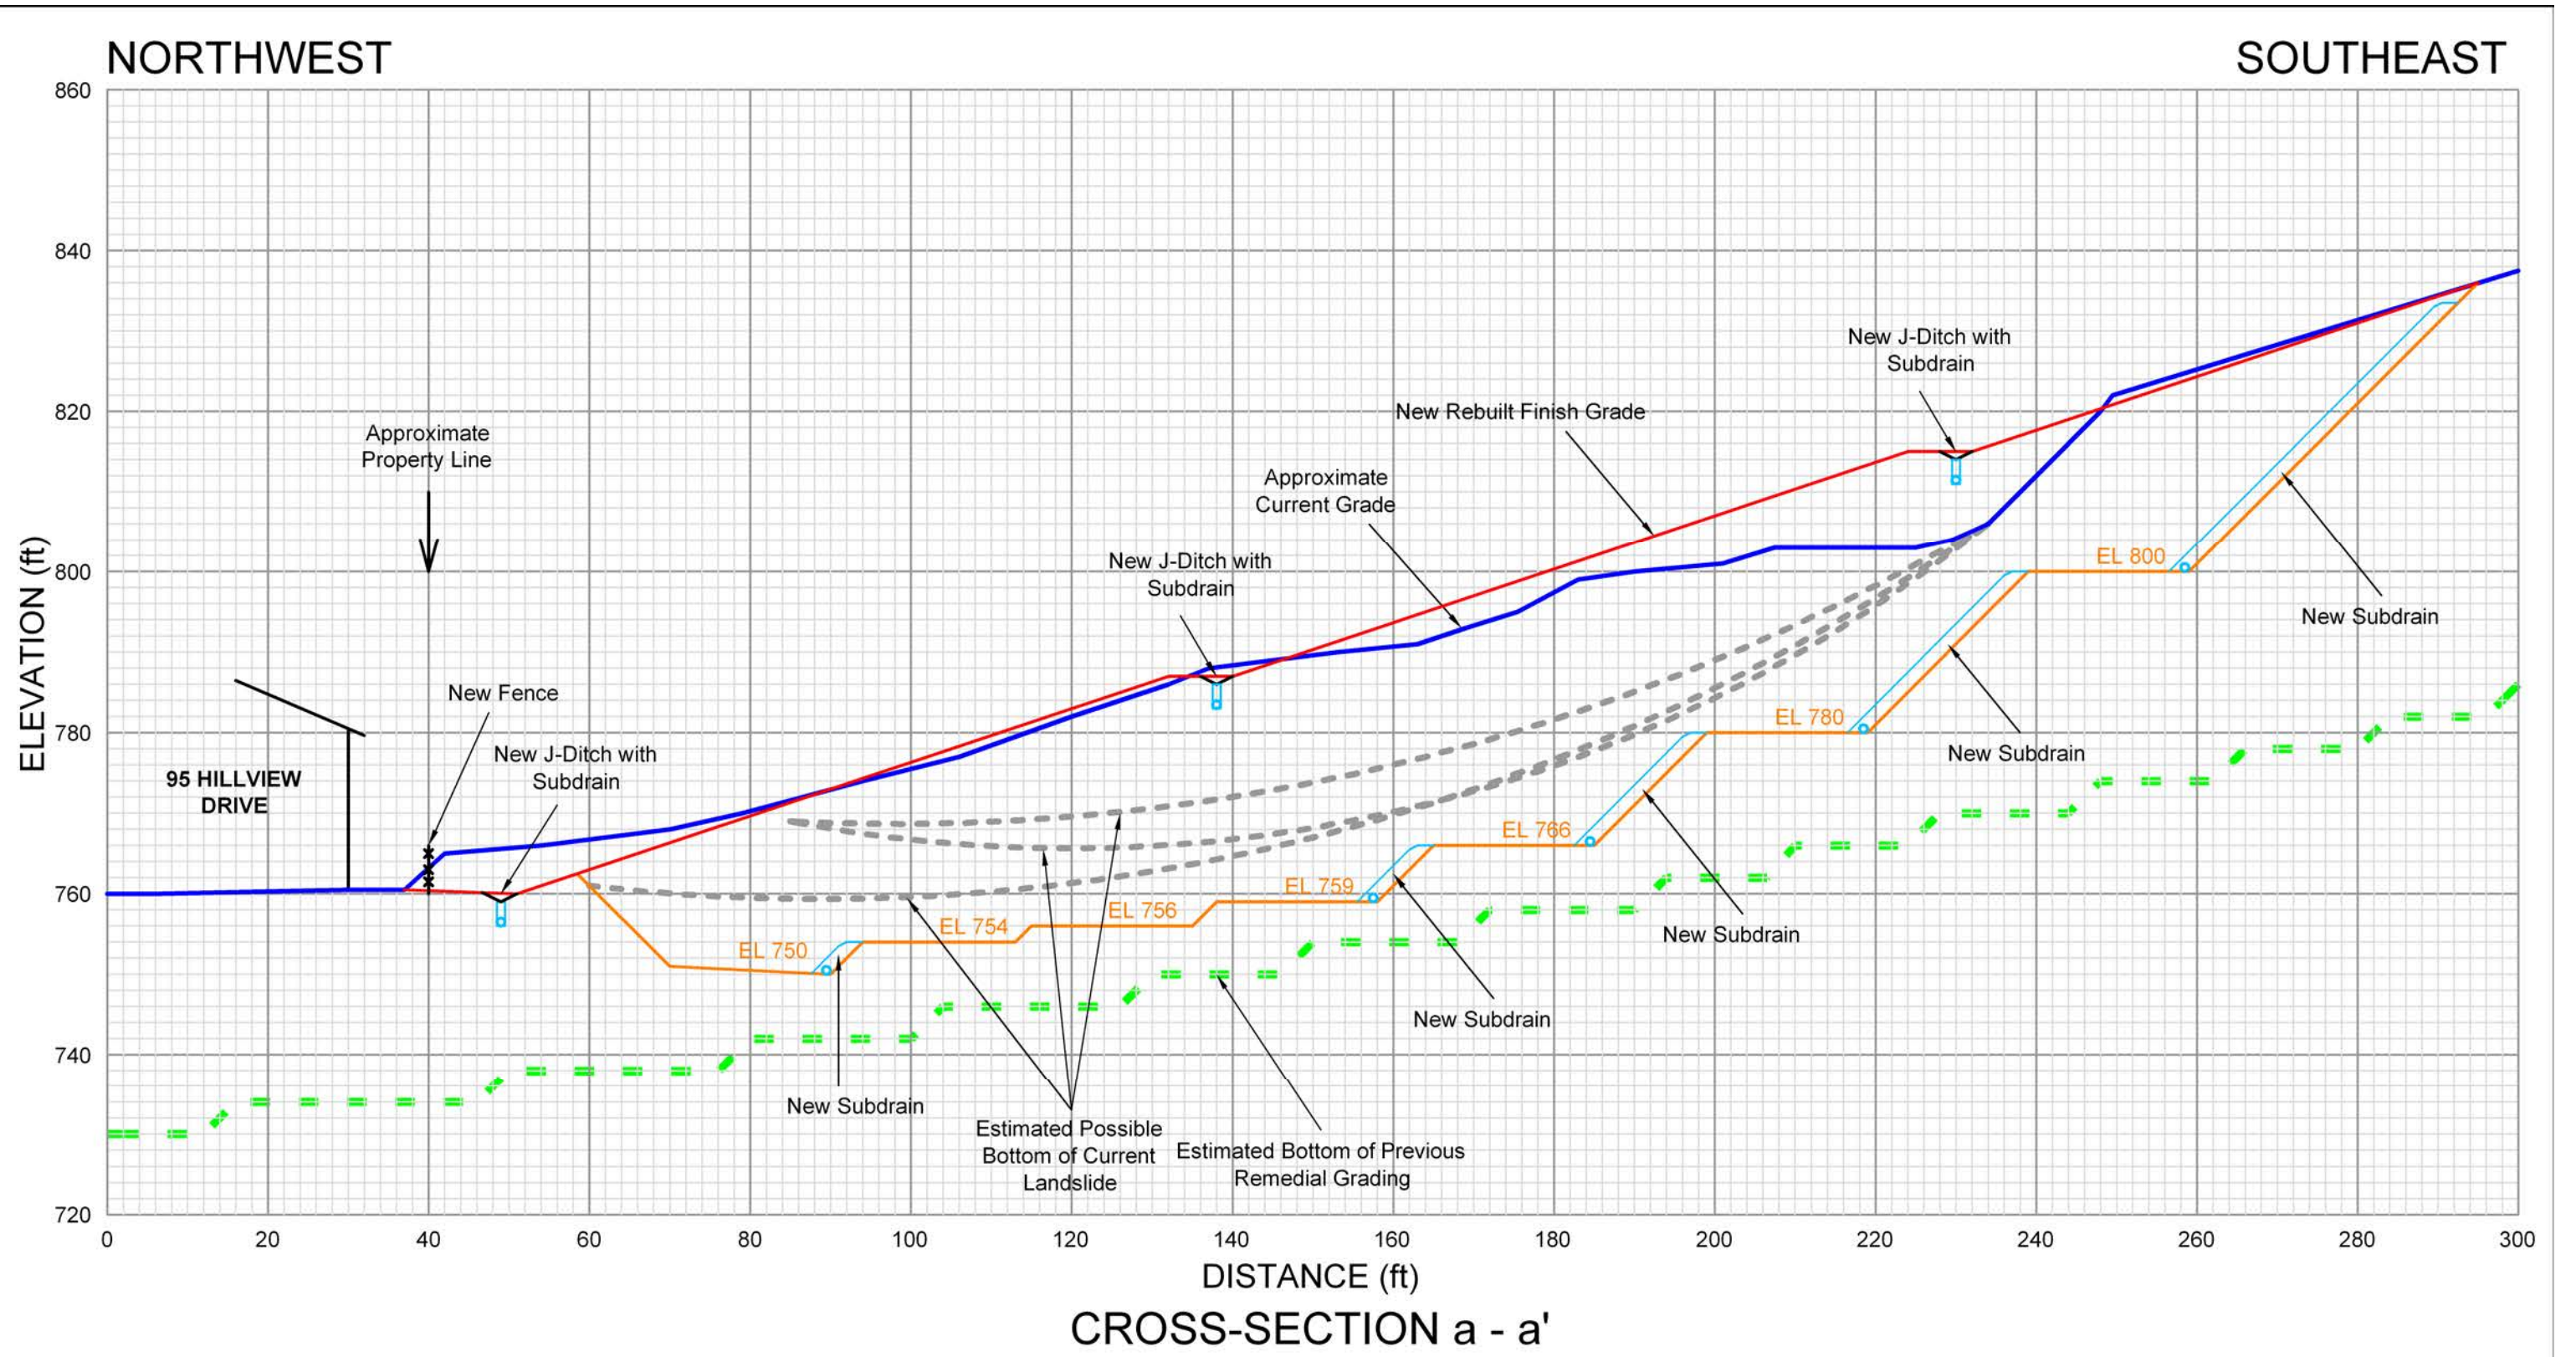
Cross-Section a-a'	Factor of Safety against Sliding	
	Static	Pseudo-Static (Earthquake Loading k = 0.25)
Proposed Slope Repair (No Groundwater)	1.87	0.96
Proposed Slope Repair (Groundwater within Existing Fill but not within Rebuilt Fill)	1.75	0.86

The results of our slope stability analyses indicate that the factor of safety against sliding under static conditions after the proposed slope repair is completed is greater than the generally acceptable value of 1.5 for the most critical potential slide plane. For the major earthquake loading condition, a factor of safety against sliding of 0.96 was calculated, which is very close to 1.0 (in order to pass screen criteria outlined in the SCEC publication) when applying the seismic coefficient of 0.25. Therefore, it is our opinion the proposed slope repair shown on the proposed repair plans is appropriate for the site.

Our recommended slope repair which includes removal of the existing landslide debris, installation of subdrains, and keying and benching of proposed compacted, engineered fills is shown on the attached **Figures 4 and 5**. The representative Cross-Section a - a' (**Figure 5**) was used for our slope stability analyses of the proposed slope repair grading. The table below summarizes the most critical results of our slope stability analyses of the proposed slope repair grading along Section a - a' under both static and pseudo-static conditions. The cross-section profiles, soil and rock engineering properties used in the analyses, and the detailed results of the analyses are presented on the computer program printouts in the attached **Appendix D**.

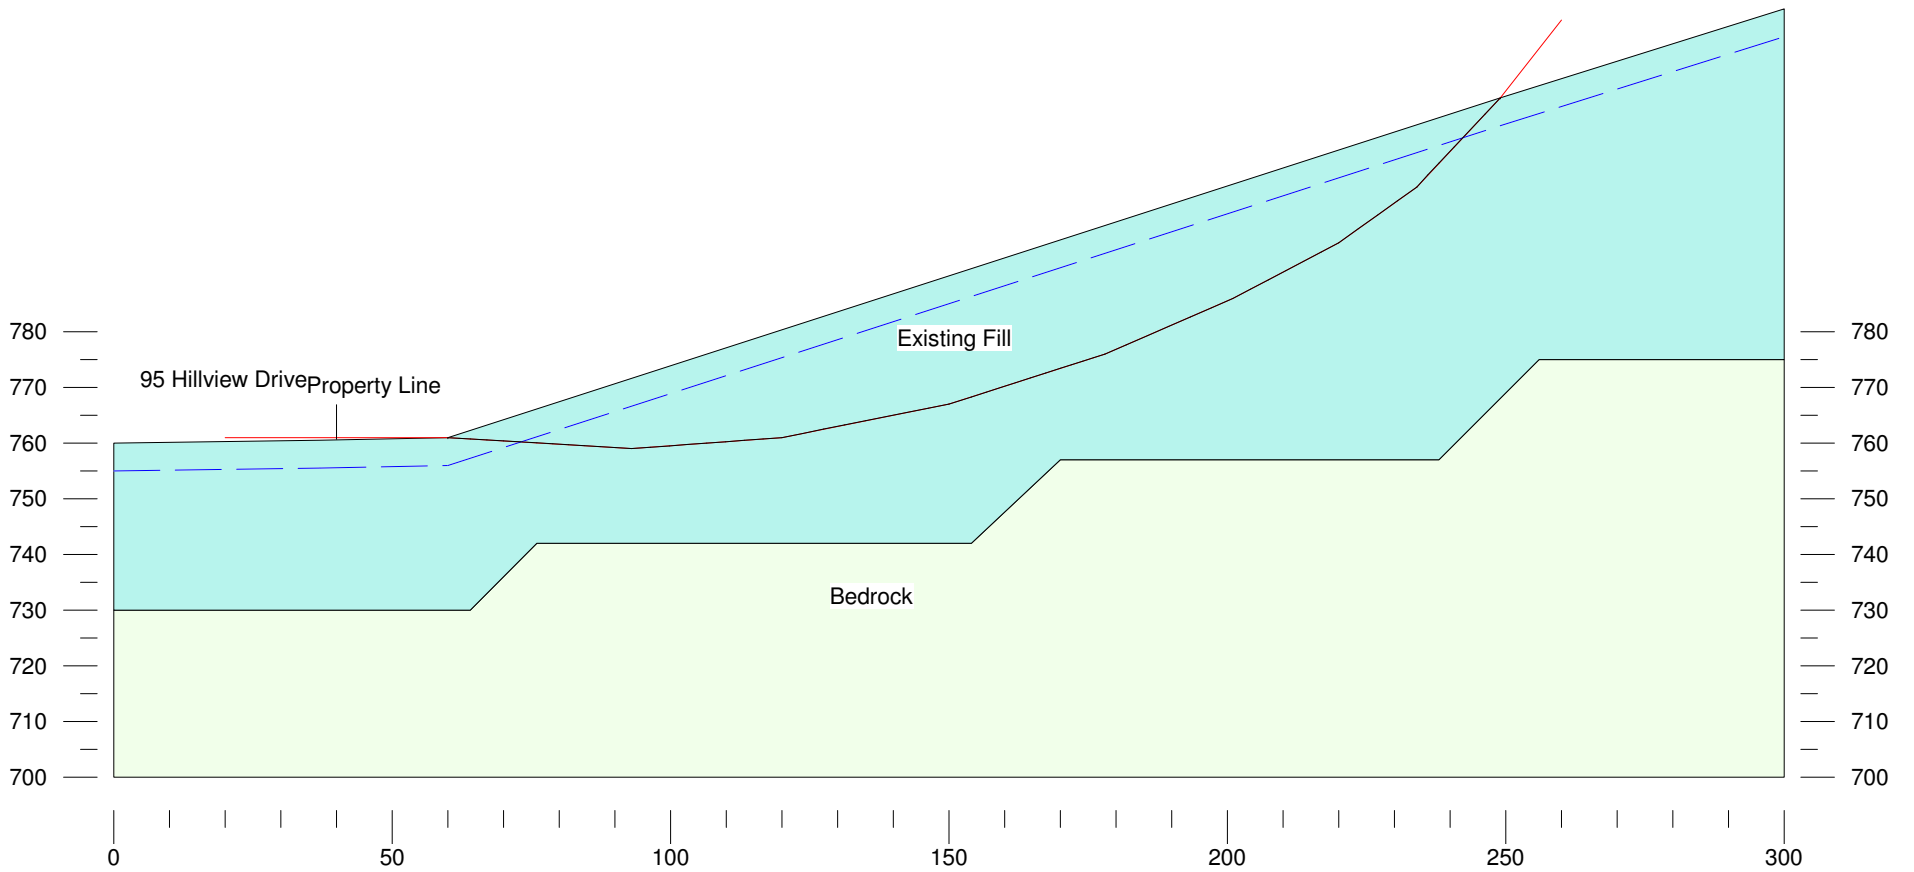
Stevens Ferrone & Bailey Engineering Co. Inc.
 SFB 768-1
 Hillview Drive Landslide, Danville, CA
 Section A
 Back Calculation - Plane 1
 With Groundwater at 5' Deep

F = 0.992

Gamma	C	Phi	Piezo	Ru
	pcf	psf	deg	Surf.	
Existing Fill	120	0	25.2	1	0
Bedrock	125	100	30	0	0

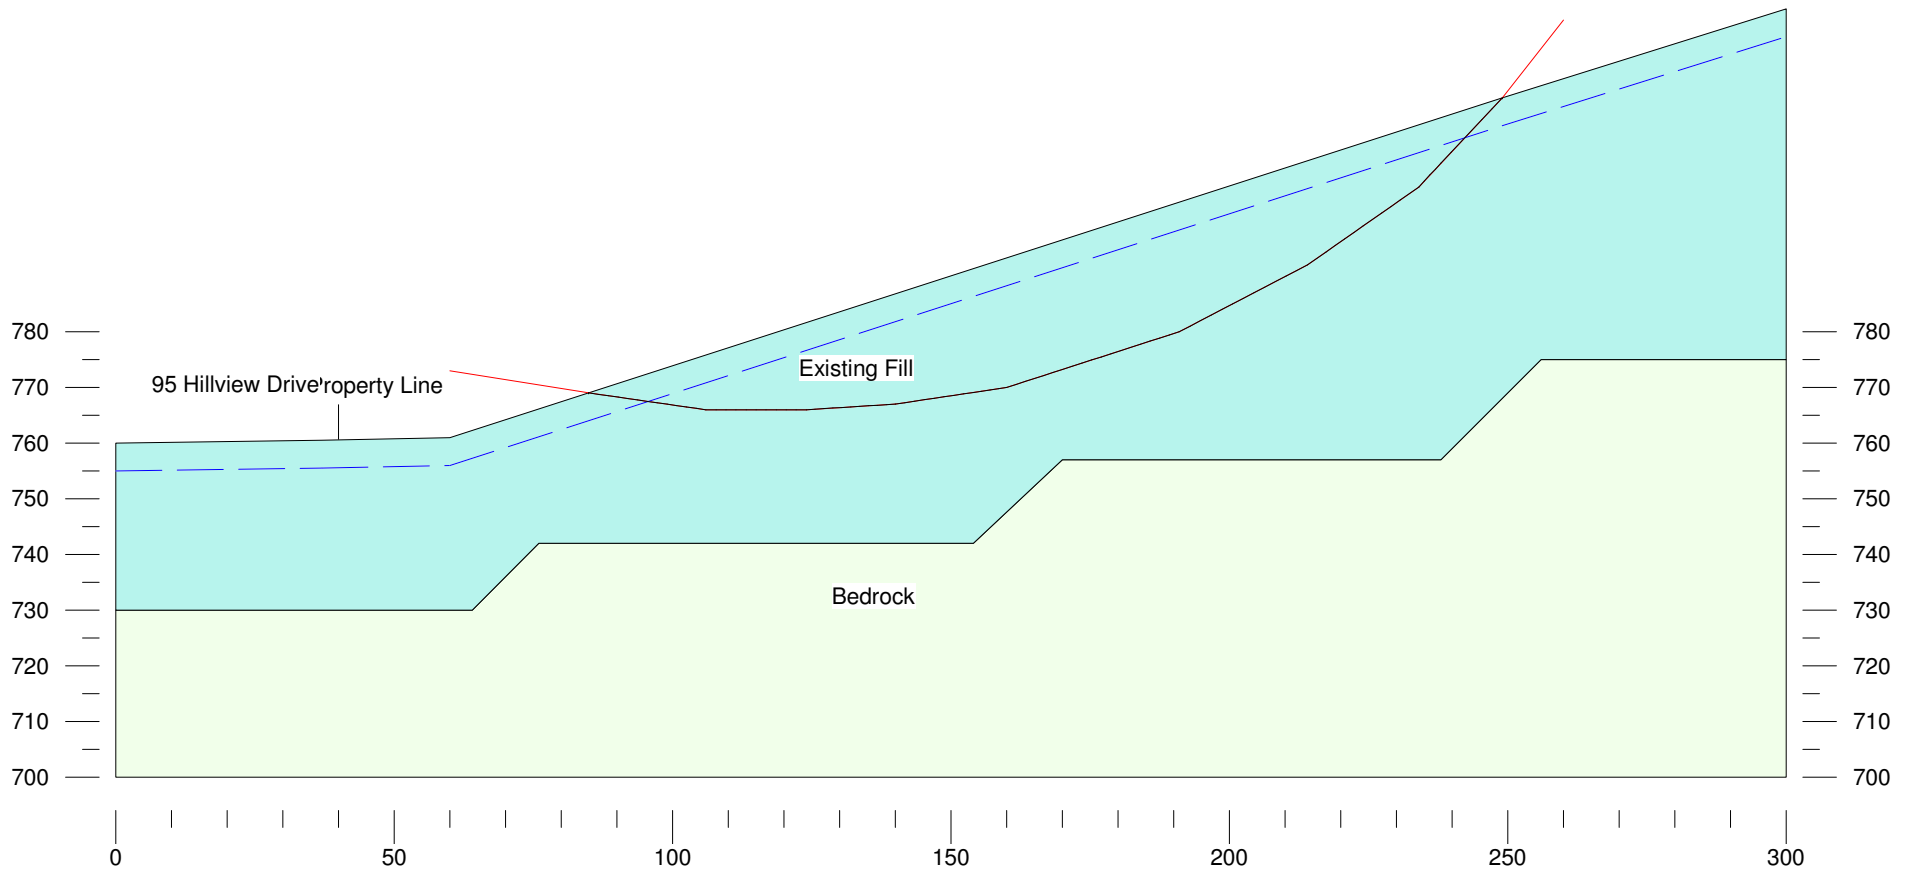
Stevens Ferrone & Bailey Engineering Co. Inc.
SFB 768-1
Hillview Drive Landslide, Danville, CA
Section A
Back Calculation - Plane 2
With Groundwater at 5' Deep

Gamma	C	Phi	Piezo	Ru
	pcf	psf	deg	Surf.	
Existing Fill	120	0	24.7	1	0
Bedrock	125	100	30	0	0
