July 12, 2017

Re: Supplemental Report for Hillview Drive Slope Repair
Vista Tassajara, Danville, California
SFB Project No.: 768-1

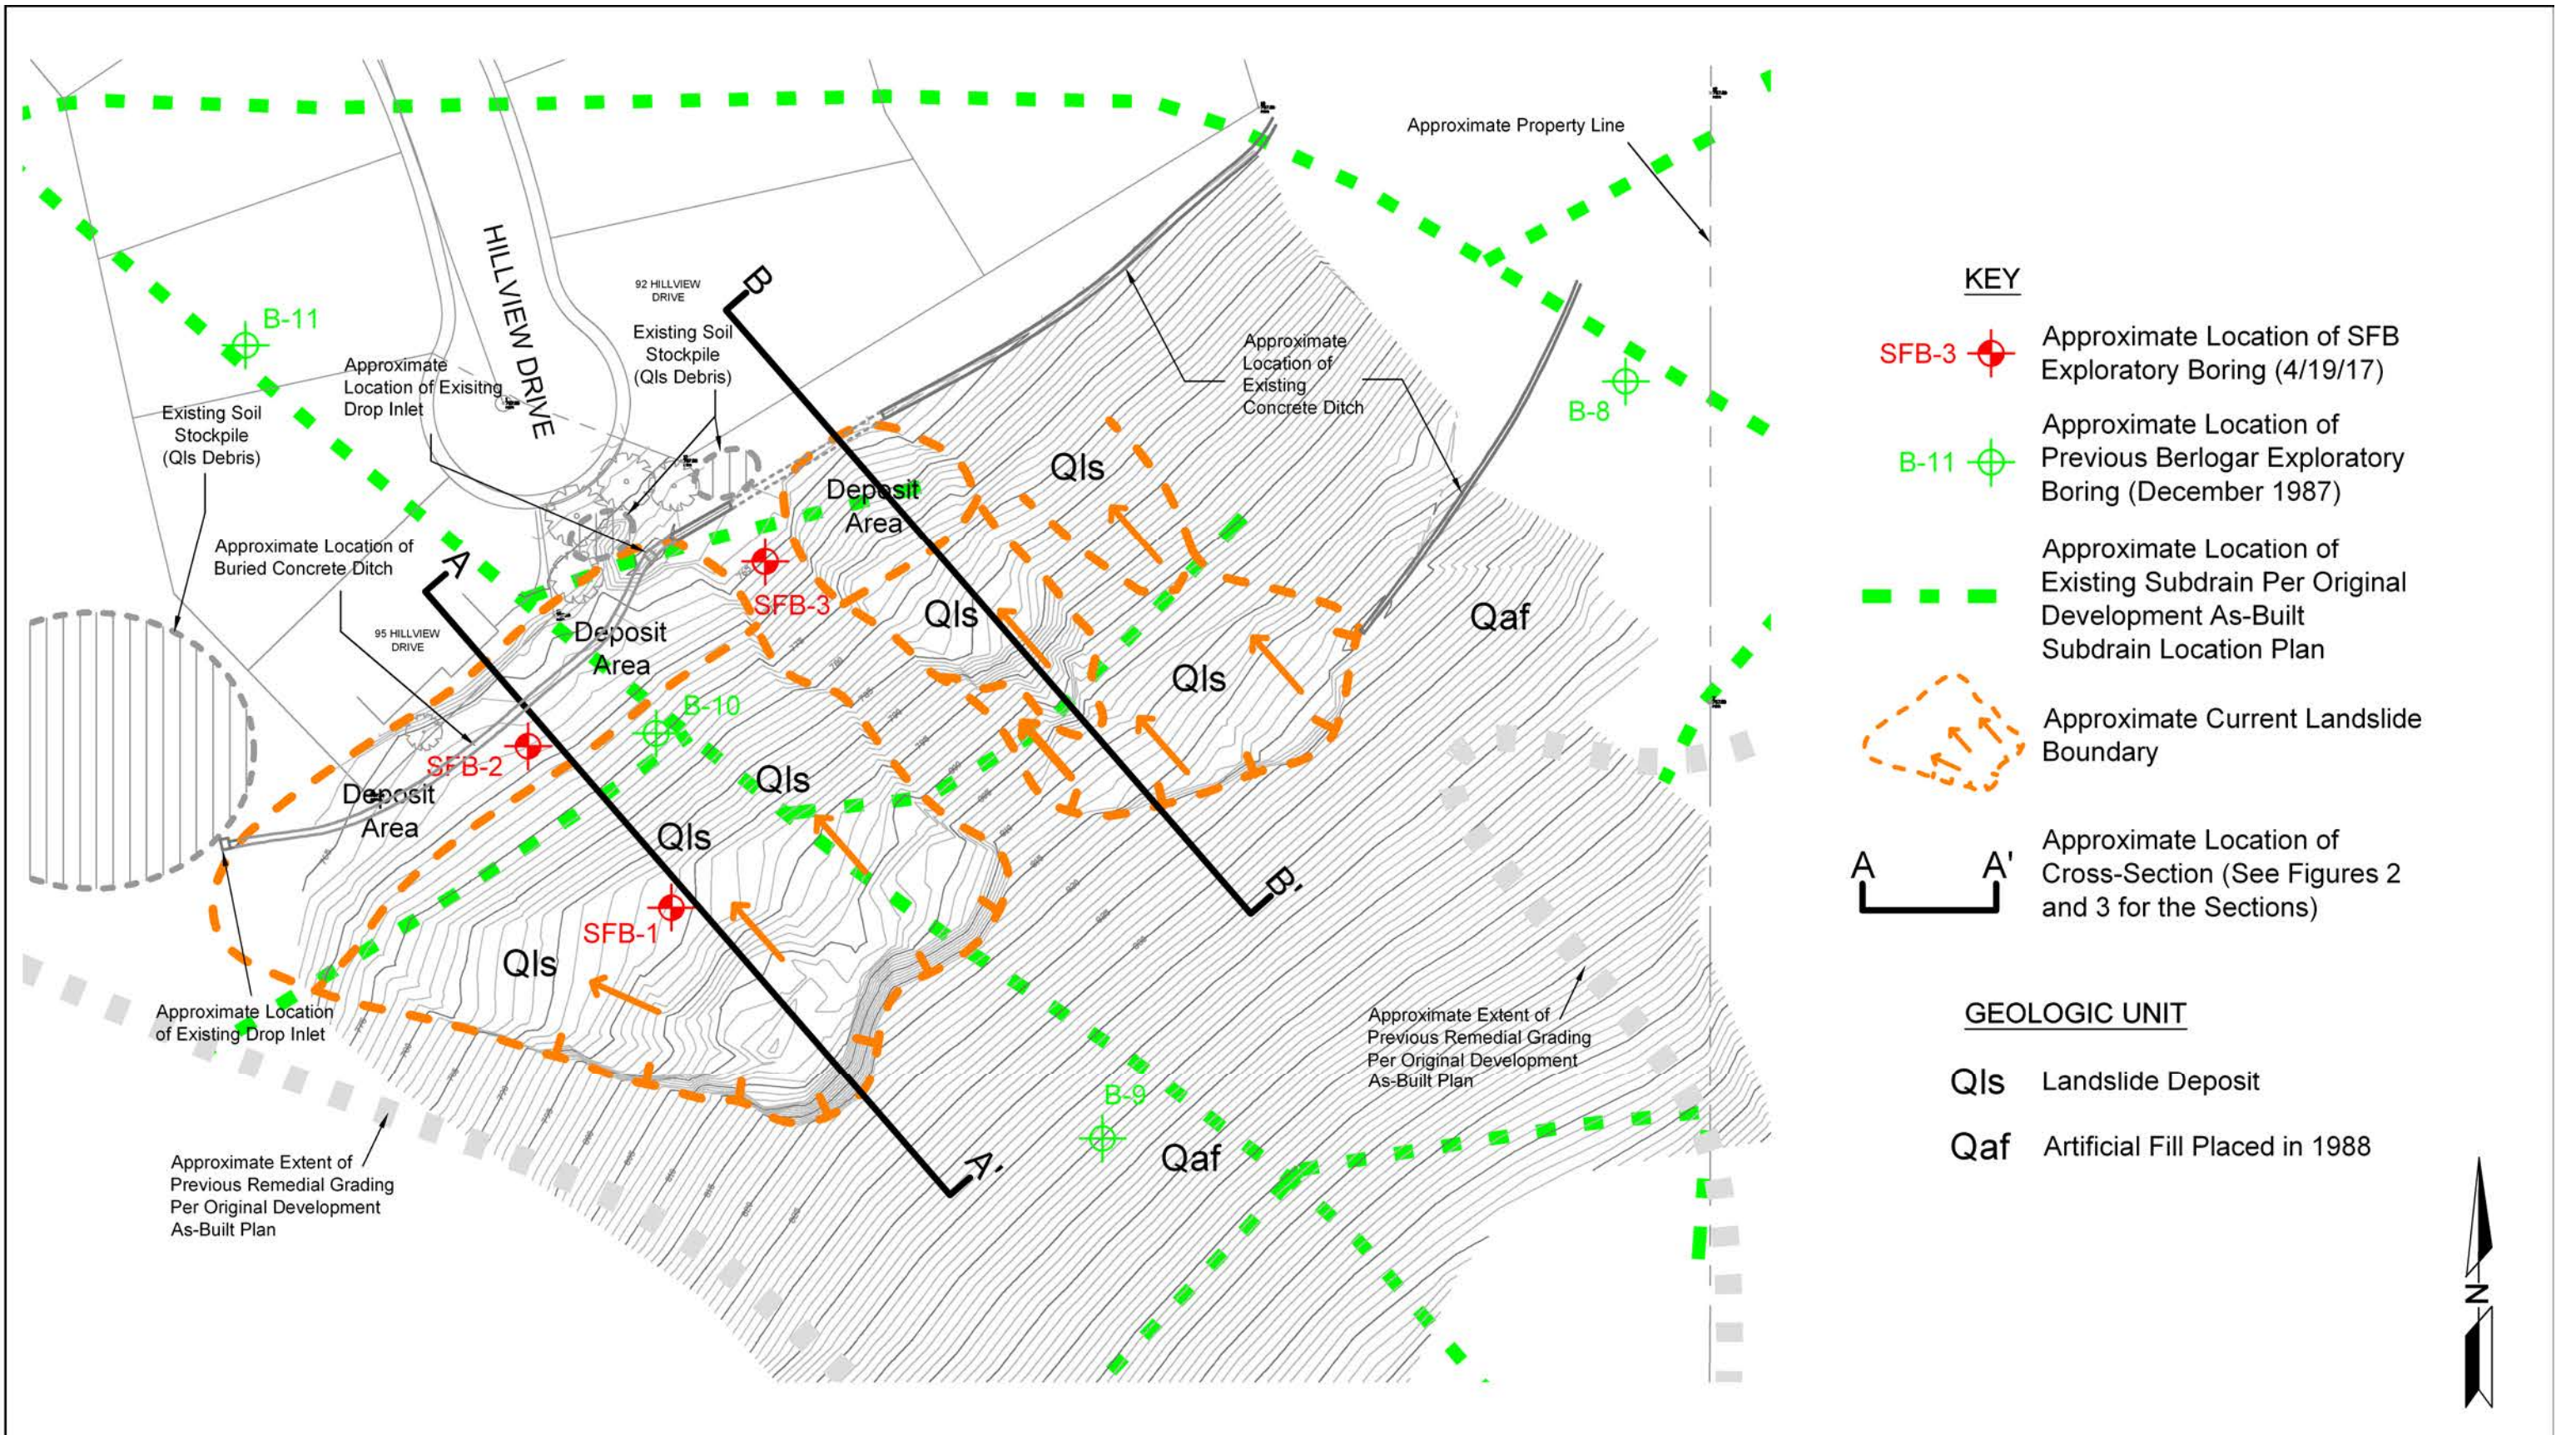
CEG Comment 3 Response: The 1988 subdrains are shown on the attached Figure 1 (Site Plan) and the attached Figures 2 and 3 (Cross-Sections). The 1988 as-built subdrain plan only shows the approximate plan view of the subdrains and does not show at what elevations the subdrains are located. Based on our understanding of the Berlogar Geotechnical Consultants (BGC) report for the 1988 grading project, the subdrains were to be placed at the bottom of over-excavations and keyways. In the area of the Hillview Drive landslide repair project, the 1988 subdrains therefore should be located at the interface between bedrock and the 1988 fill materials. Our interpreted depths (based on BGC reports) of over-excavation performed in 1988 are shown on our cross-sections in our previous report and on Sheet 5 of the plans. We don't anticipate encountering any of the 1988 subdrains since the current landslide has occurred within the existing fill materials as shown on our cross-sections. If any of the 1988 subdrains are encountered, the encountered 1988 subdrains will be properly connected to a drainage system so that they can continue to function. This task will be added to the project plans as a remedial slope grading note on Sheet 1. As shown on Sheet 6 of the plans, the lowermost subdrain is planned to discharge at the existing concrete v-ditch located in the open space area to the west of the landslide repair site (see plan sheet 2 for a view of the v-ditch). The elevation of the lowermost subdrain discharge location is at approximately 730 feet, significantly lower than the planned lowermost keyway/subdrain elevation of 750 feet at the repair site.

headscarp and toe of each landslide and areas of deposition were located and mapped. Sheet 4 of the plans and Figure 1 of the report shows the results of this mapping. No evidence of ground movement was observed above the headscarp or beyond the toe of the landslides. The highly plastic characteristics of the relatively homogenous clayey fill materials also show that the basal shape is relatively circular in the more critical deeper landslides. Three possible and conservative landslide planes (as shown on Sheet 5 of the plans and on Figures 2 and 3 of the report) were determined by projecting the headscarp shape through the zone of the potentially deepest section of the landslide bottom and downward toward the toe of the landslides, resulting in a relatively circular shape. As described in our previous June 5, 2017 report in Section 4.0, we also performed slope stability back calculations along these three possible landslide planes to estimate the friction angle of the existing hillslope fill materials. In addition, it is our opinion that none of the shear planes intercept the bottom of the over-excavations performed in 1988 (based on our interpretation of the 1988 grading), therefore, the landsliding has occurred wholly within the previously placed fill materials and the underlying bedrock is not a factor in the recent slope instability. **During the construction phase of this project, the existing landslide shear planes will be completely over-excavated to whatever depth is needed to completely remove the shear planes.**

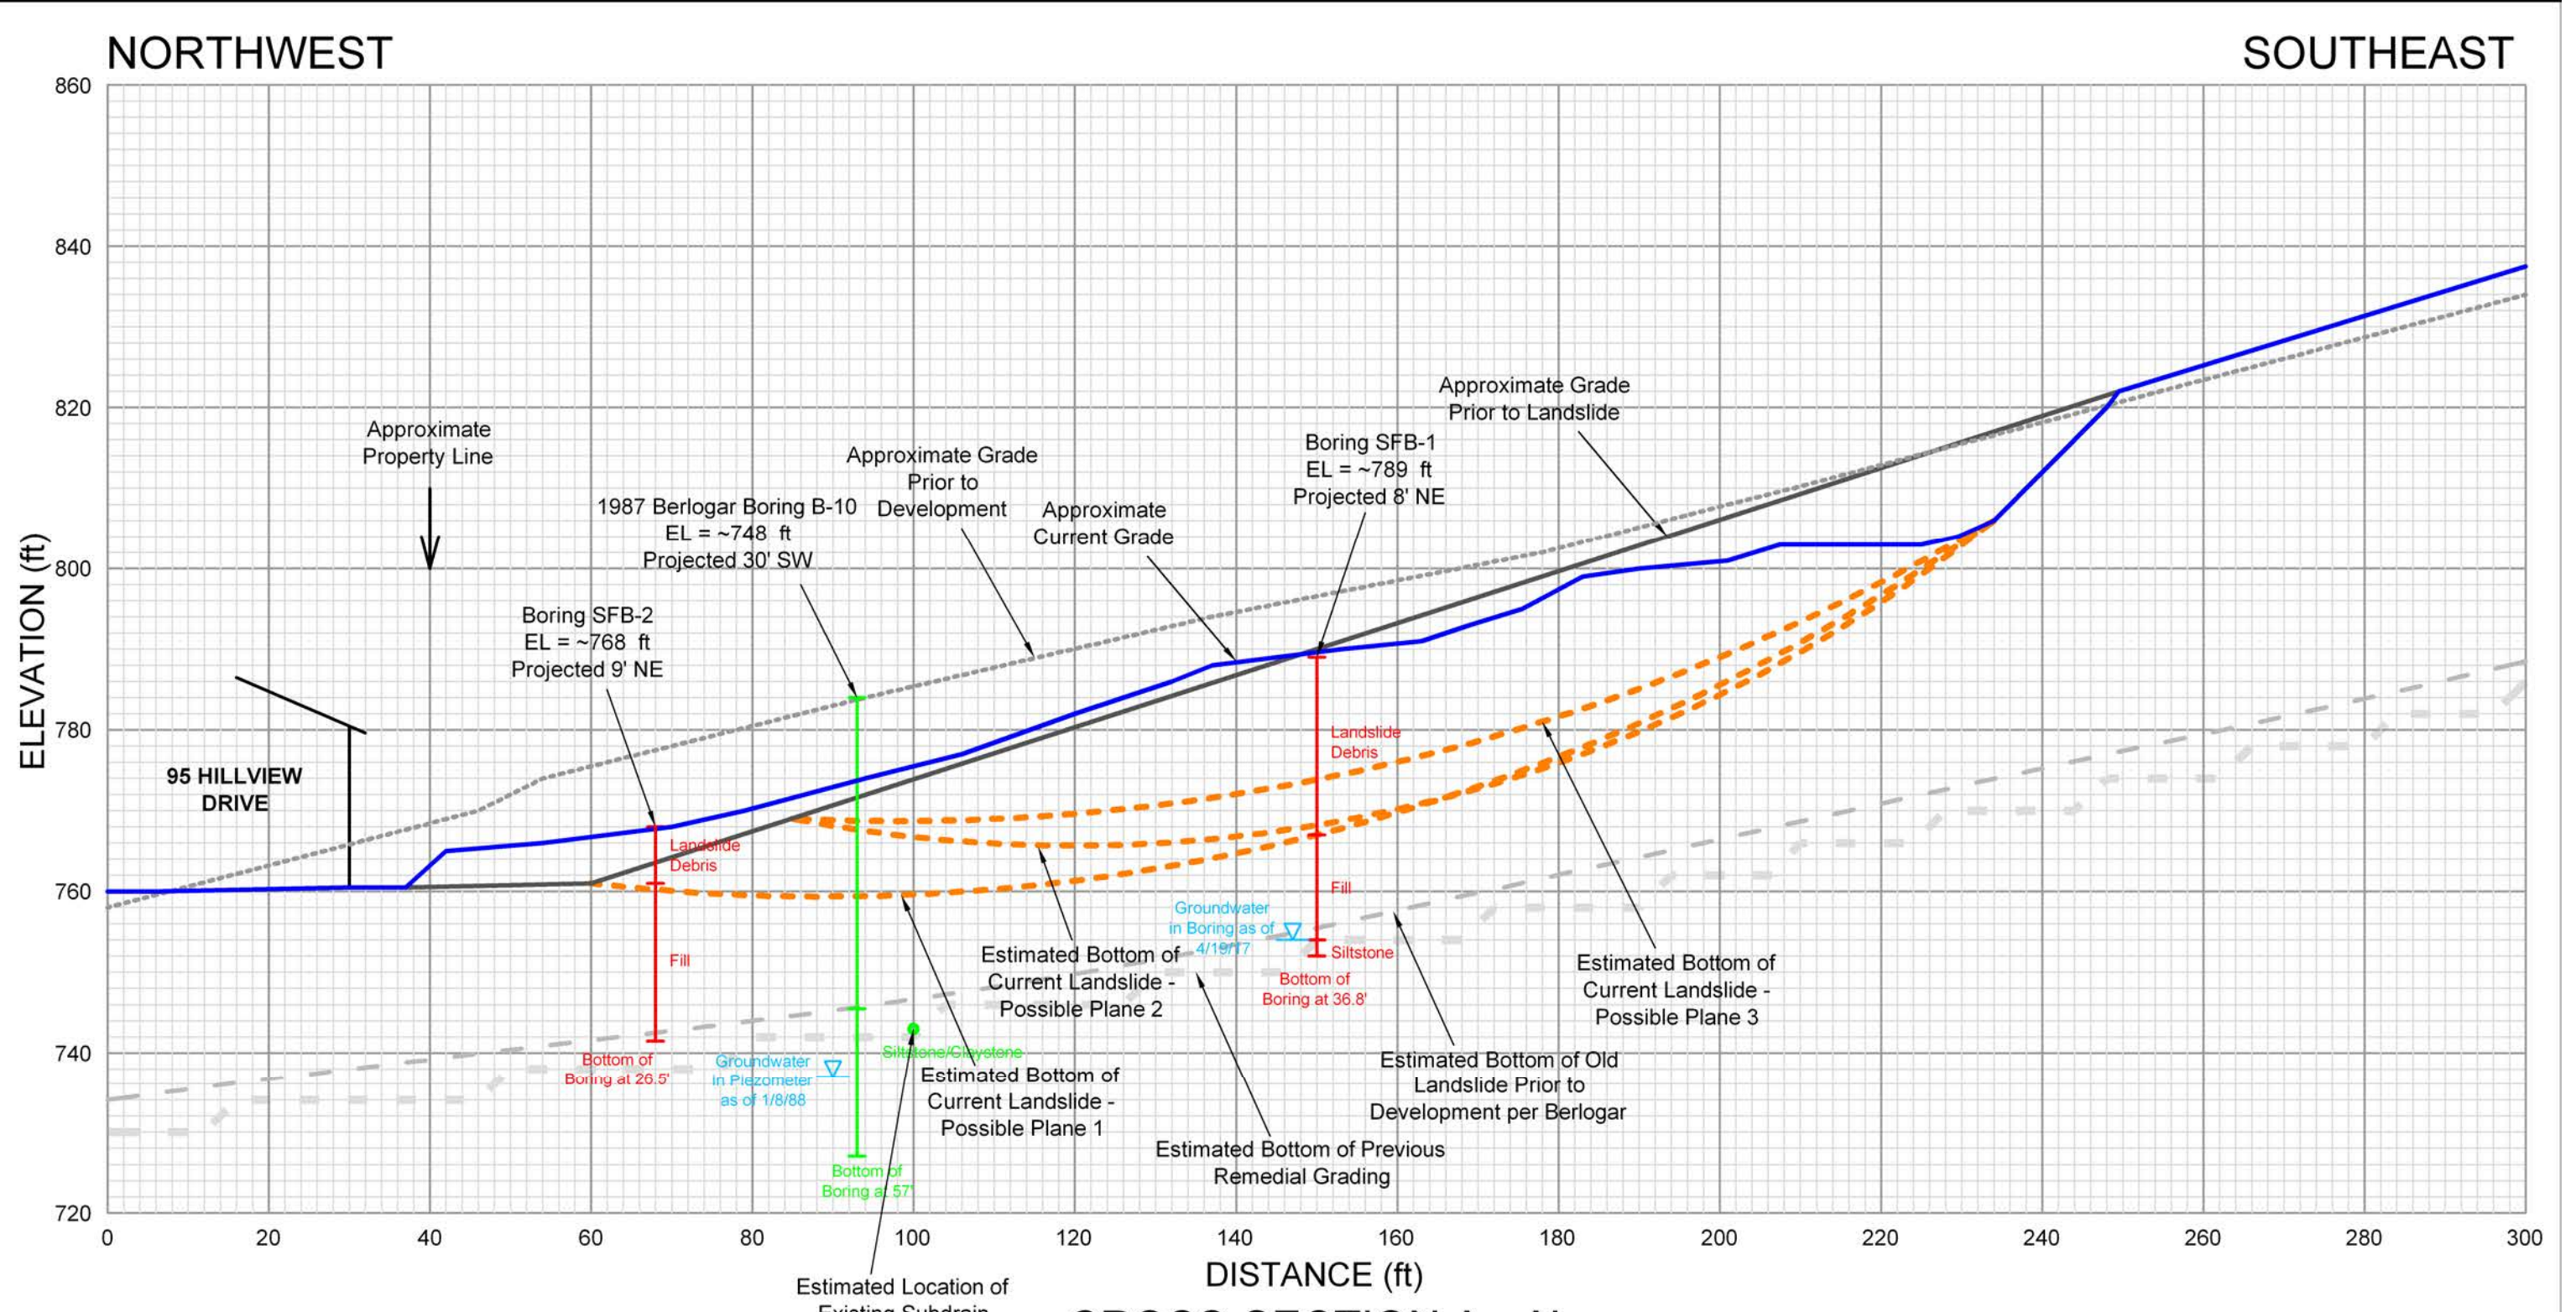
FIGURE
2

Cross-Section a-a'	Factor of Safety against Sliding		
	Static	Pseudo-Static (Earthquake Loading $k = 0.25$)	Seed Procedure Pseudo-Static (Earthquake Loading $k = 0.15$)
Proposed Slope Repair (Groundwater at Fill/Bedrock Interface)	1.87	0.96	1.20

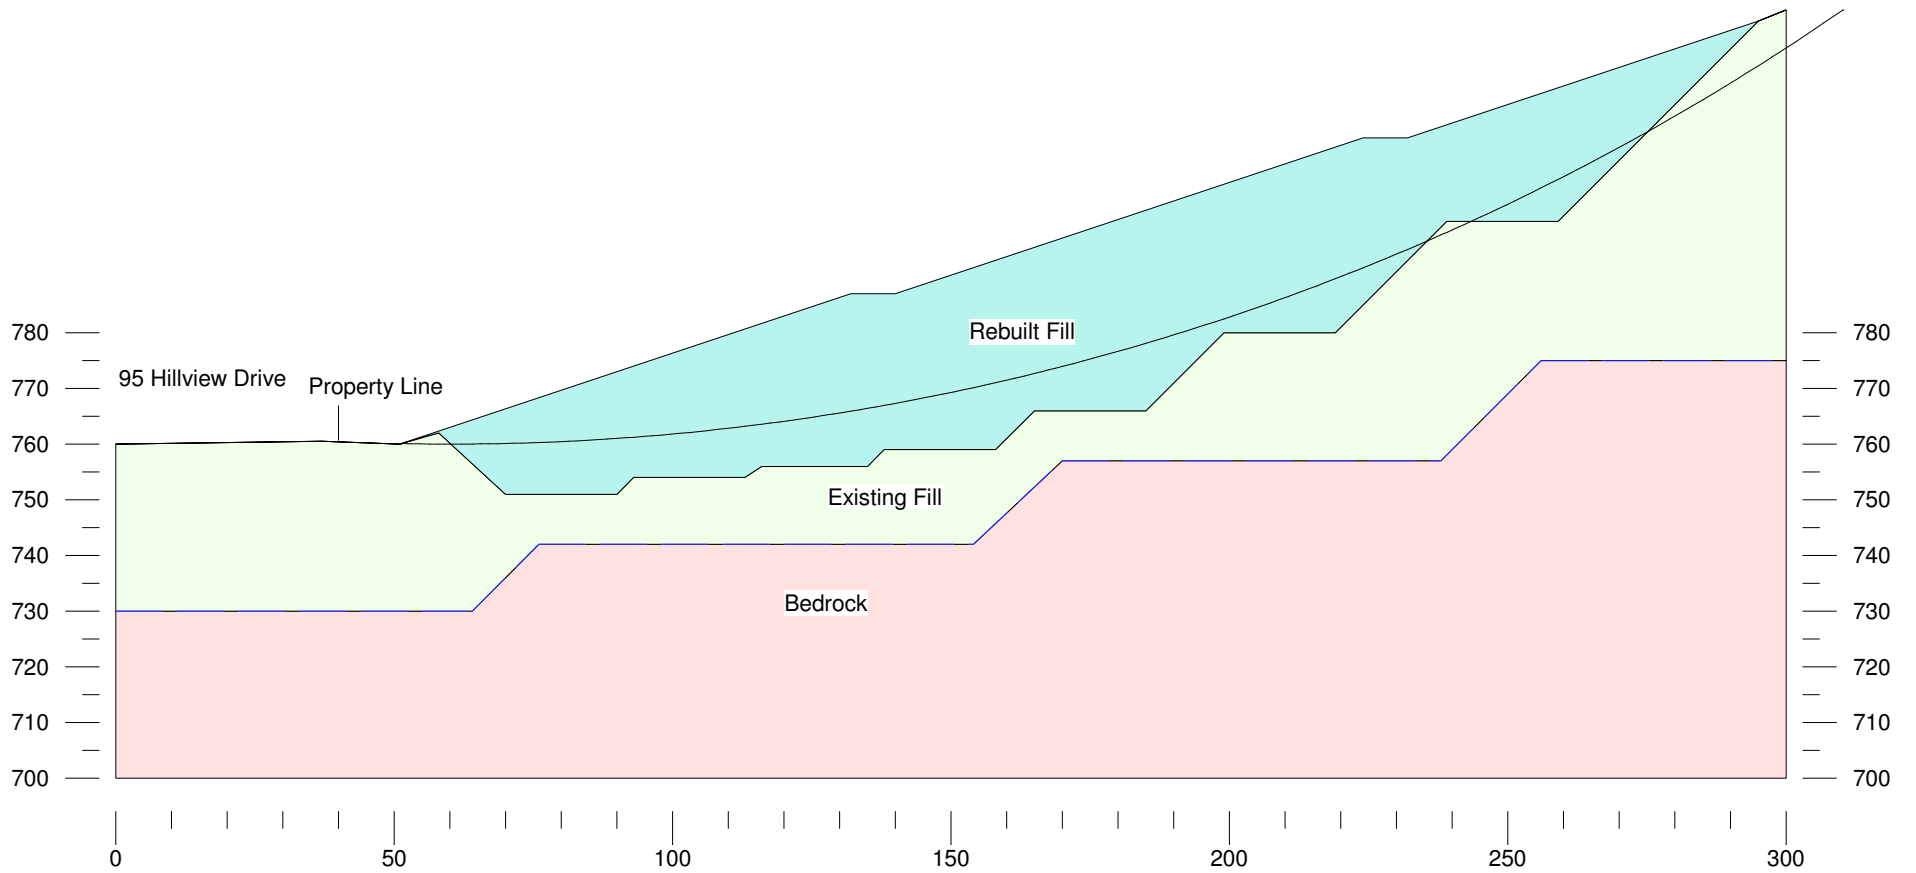
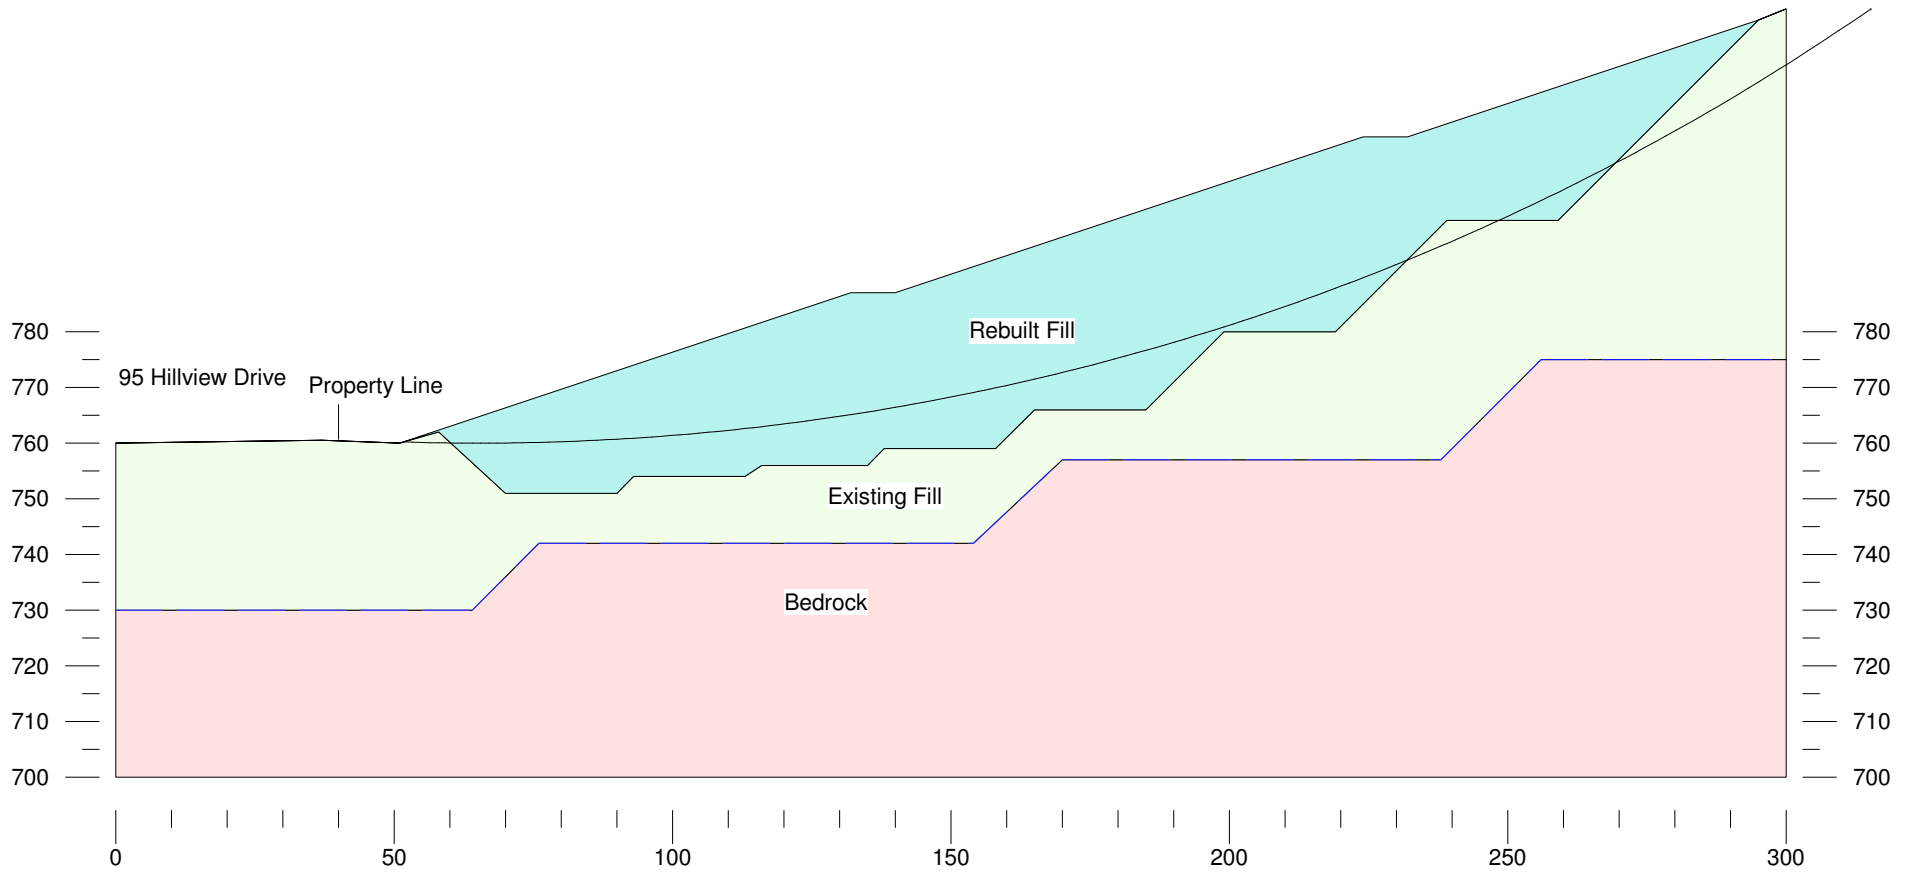
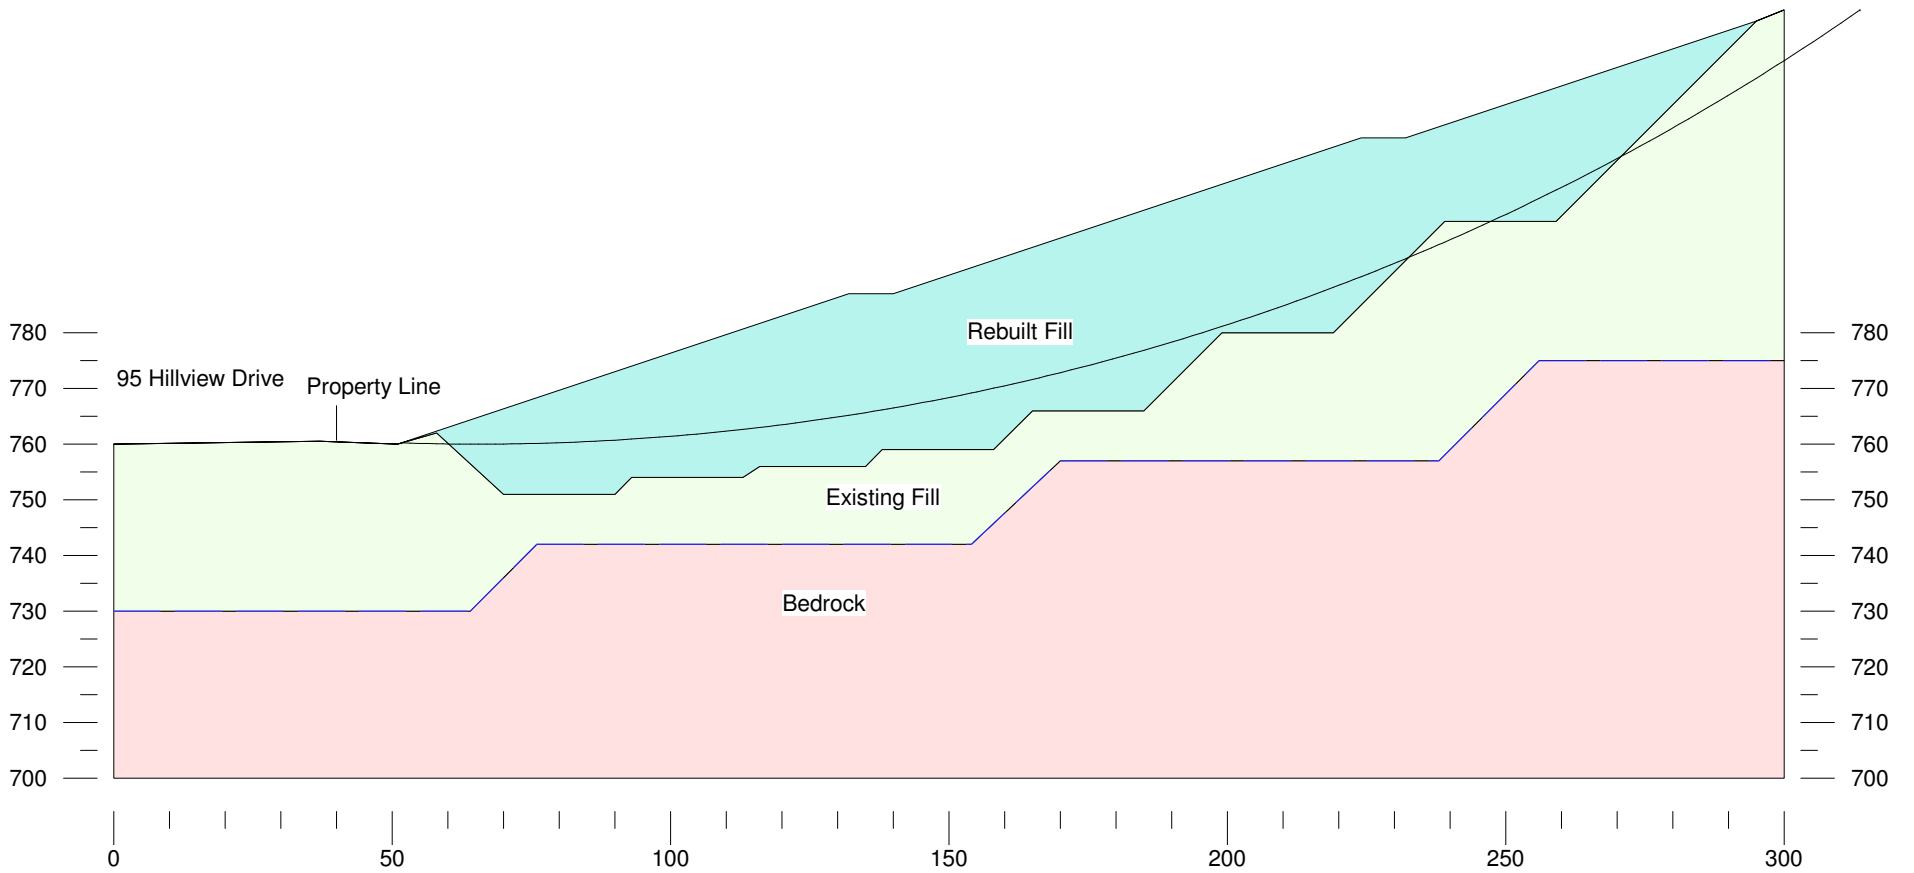
In order to directly respond to the last sentence of CEG Comment 1, we performed additional slope stability analyses assuming groundwater is located at the existing fill/bedrock interface (which assumes the 1988 subdrains are present and functional). We do not have any information to suggest that the 1988 subdrains are not present or not functional. By placing the groundwater surface at this interface, this condition results in the bedrock being affected by groundwater induced pore water pressures. The results of this slope stability condition analysis are attached in Appendix A. The static factor of safety in this case is 1.87 and the seismic factor of safety in this case is 0.96 which represents the slope performance index when the slope is subjected to a major earthquake (as explained above).

For comparison purposes, we performed additional slope stability analyses using the generally accepted Seed procedure (by apply a seismic coefficient $k = 0.15$). The table below summarizes the most critical results of our slope stability analyses of the proposed slope repair grading along Section a - a' under both static and pseudo-static conditions. The results of the additional slope stability analyses (as requested by CEG) are included in the table for comparison. The result of this analysis is presented in the attached **Appendix A**.
