June 5, 2017

Re: Geotechnical Engineering Report for Hillview Drive Slope Repair
Vista Tassajara, Danville, California
SFB Project No.: 768-1

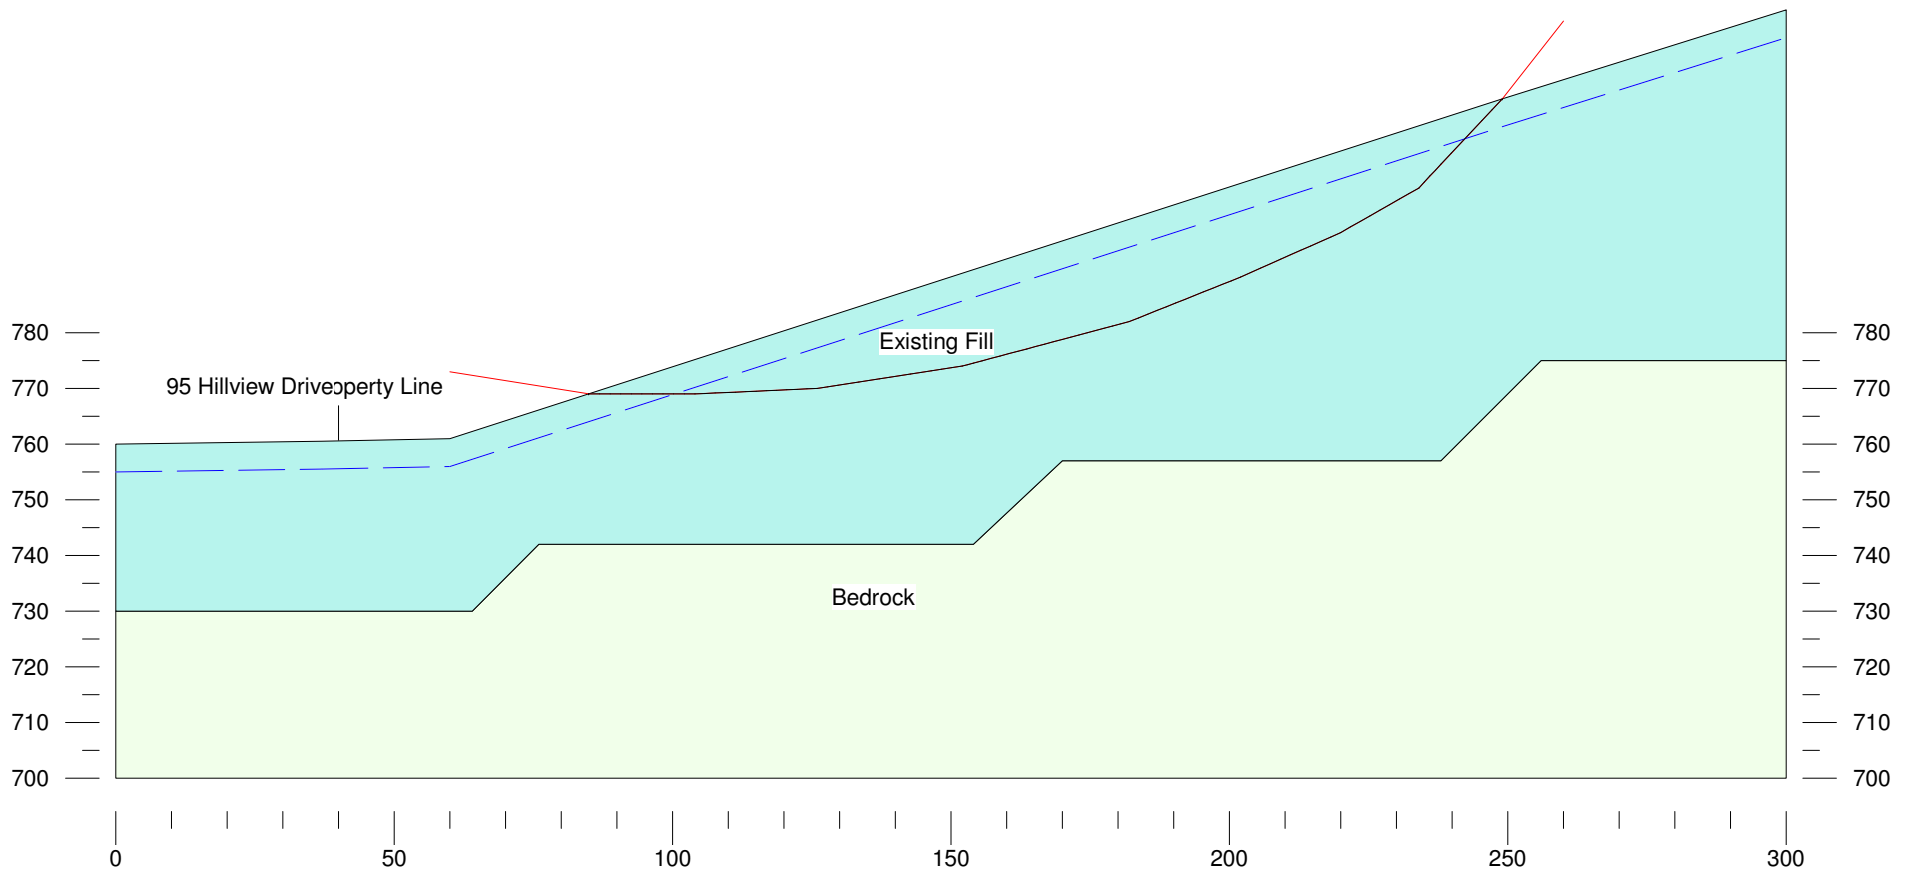
Stevens Ferrone & Bailey Engineering Co. Inc.
 SFB 768-1
 Hillview Drive Landslide, Danville, CA
 Section A
 Back Calculation - Plane 3
 With Groundwater at 5' Deep

Gamma	C	Phi	Piezo	Ru
	pcf	psf	deg	Surf.	
Existing Fill	120	0	24.7	1	0
Bedrock	125	100	30	0	0

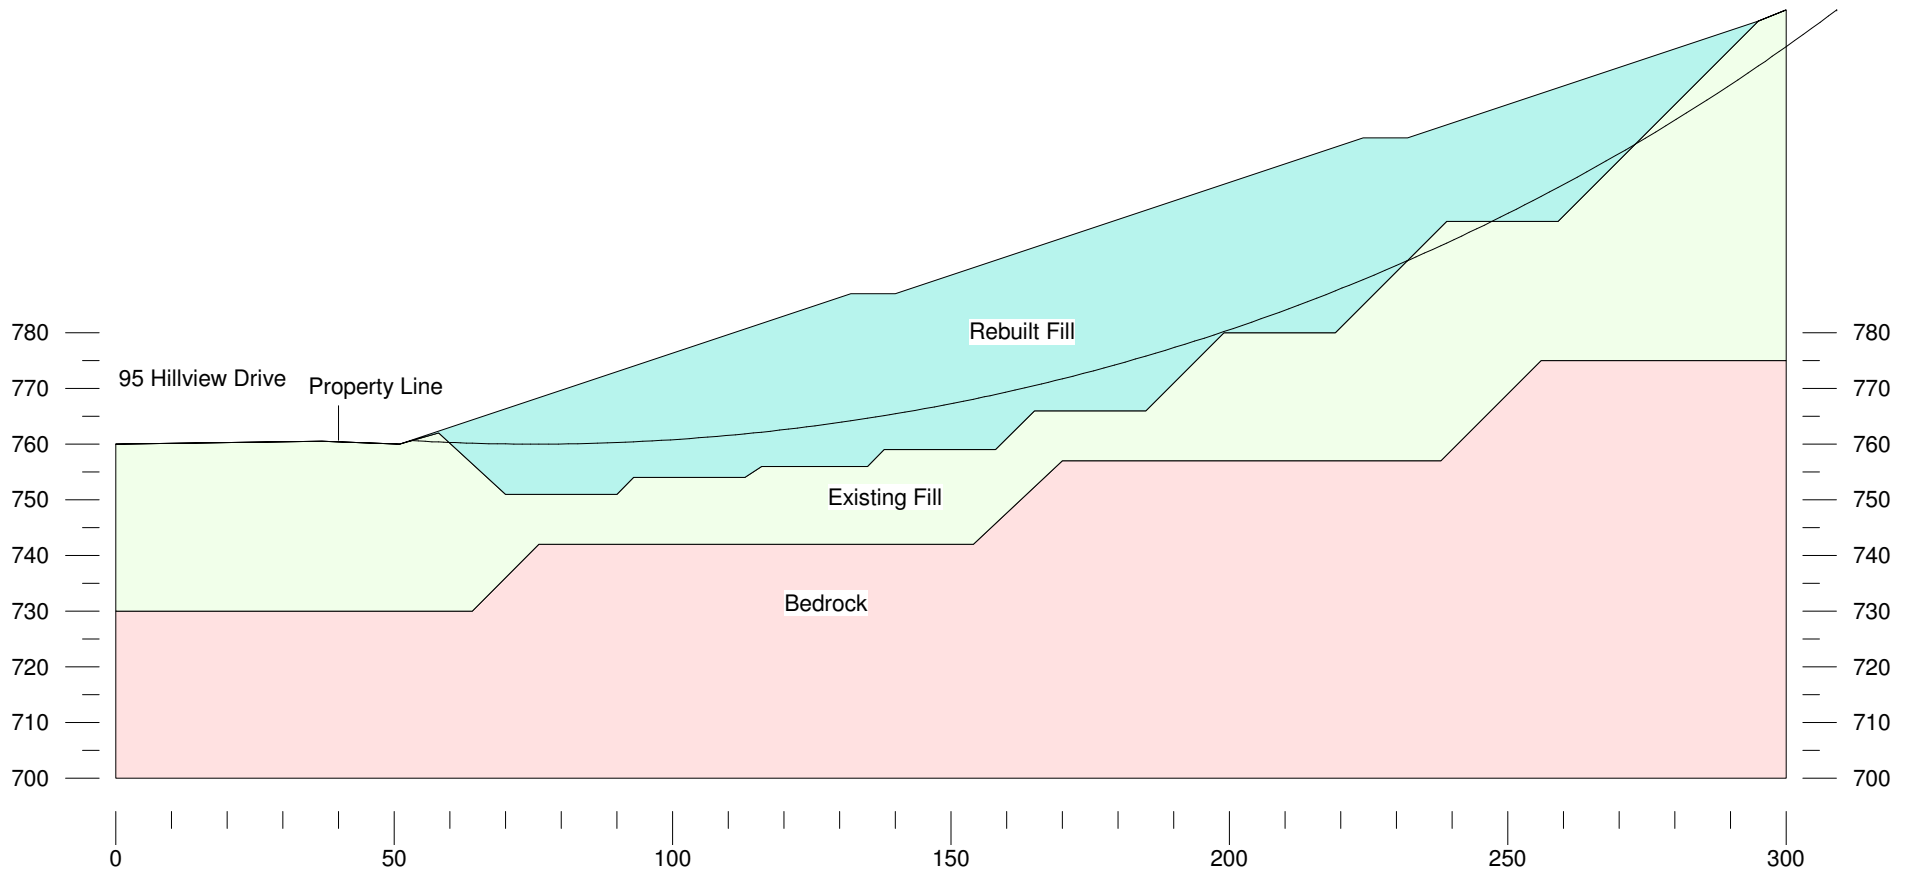
Stevens Ferrone & Bailey Engineering Co. Inc.
 SFB 768-1
 Hillview Drive Landslide, Danville, CA
 Section A
 Slope Repair without Groundwater
 Static

Gamma pcf	C psf	Phi deg	Piezo Surf.	Ru
Rebuilt Fill	120	100	26	0	0
Existing Fill	120	100	26	0	0
Bedrock	125	100	30	0	0

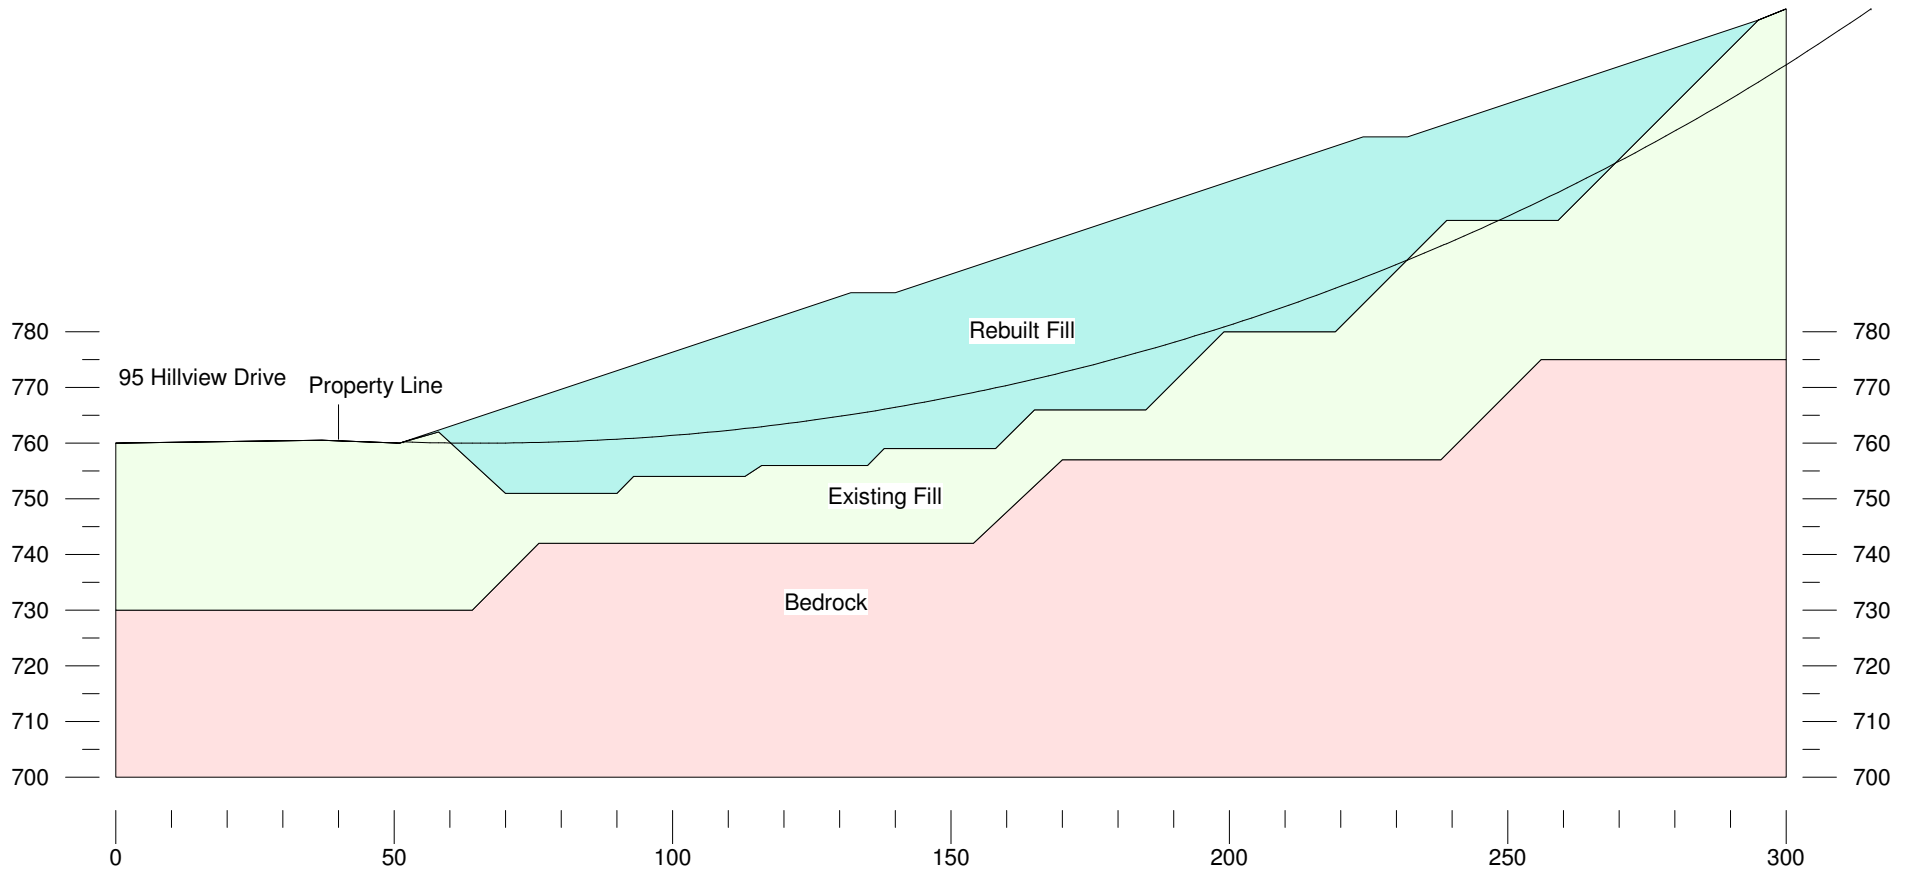
Stevens Ferrone & Bailey Engineering Co. Inc.
 SFB 768-1
 Hillview Drive Landslide, Danville, CA
 Section A
 Slope Repair without Groundwater
 Pseudo-Static

Gamma	C	Phi	Piezo	Ru
	pcf	psf	deg	Surf.	
Rebuilt Fill	120	100	26	0	0
Existing Fill	120	100	26	0	0
Bedrock	125	100	30	0	0

Seismic coefficient = 0.25

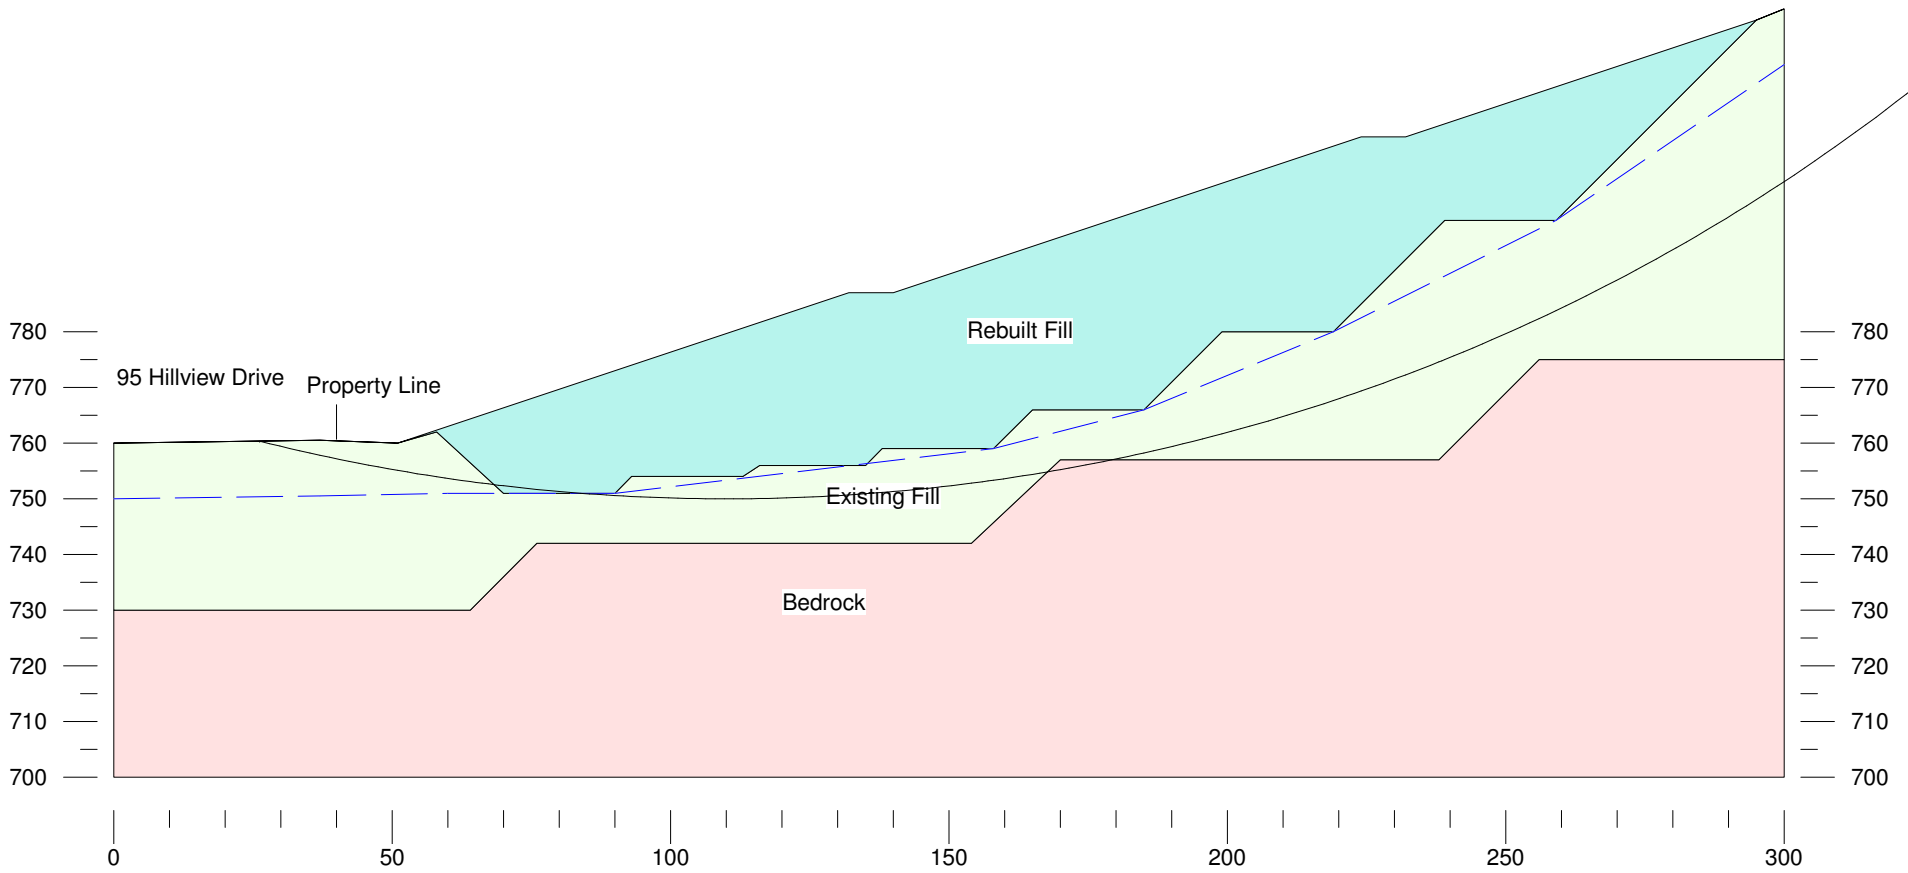
Stevens Ferrone & Bailey Engineering Co. Inc.
 SFB 768-1
 Hillview Drive Landslide, Danville, CA
 Section A
 Slope Repair with Groundwater in Existing Fill
 Static

Gamma pcf	C psf	Phi deg	Piezo Surf.	Ru
Rebuilt Fill	120	100	26	0	0
Existing Fill	120	100	26	1	0
Bedrock	125	100	30	0	0

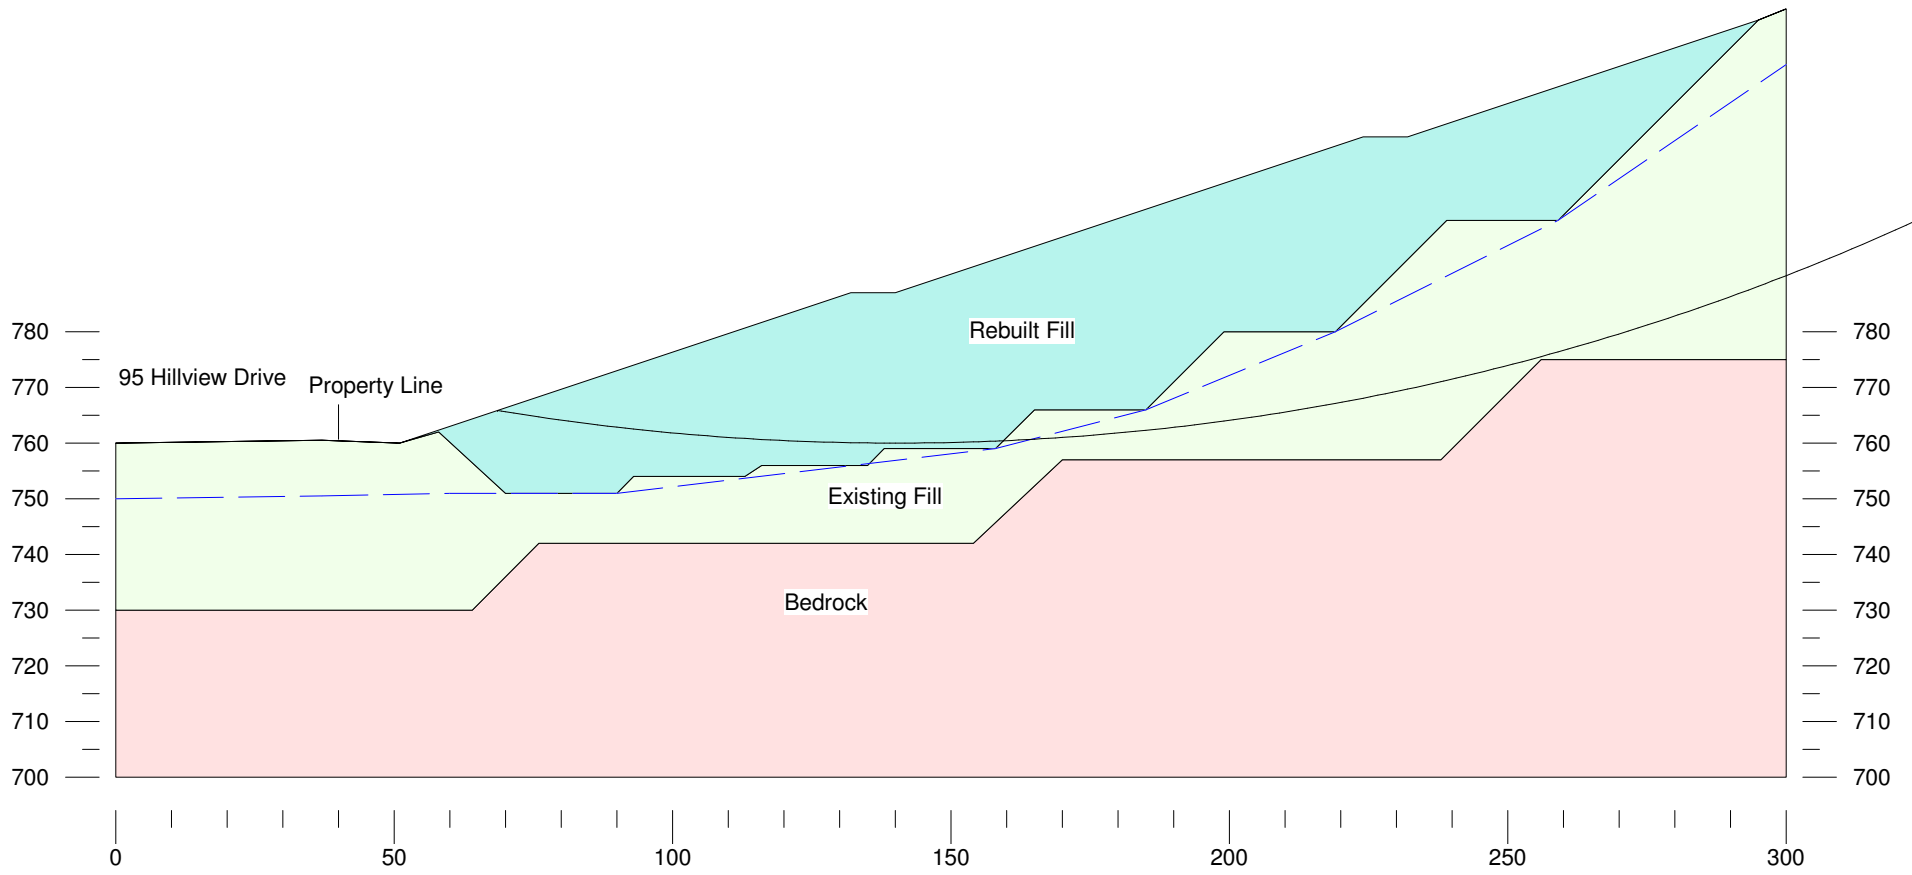
Stevens Ferrone & Bailey Engineering Co. Inc.
 SFB 768-1
 Hillview Drive Landslide, Danville, CA
 Section A
 Slope Repair with Groundwater in Existing Fill
 Pseudo-Static

Gamma	C	Phi	Piezo	Ru
	pcf	psf	deg	Surf.	
Rebuilt Fill	120	100	26	0	0
Existing Fill	120	100	26	1	0
Bedrock	125	100	30	0	0

Seismic coefficient = 0.25
